# **SMART 2 – IWRM**

### **Decentralised wastewater treatment and reuse:**

**Report on the Construction of Modified Septic Tanks  
and Treatment Wetlands**

**September 2012**

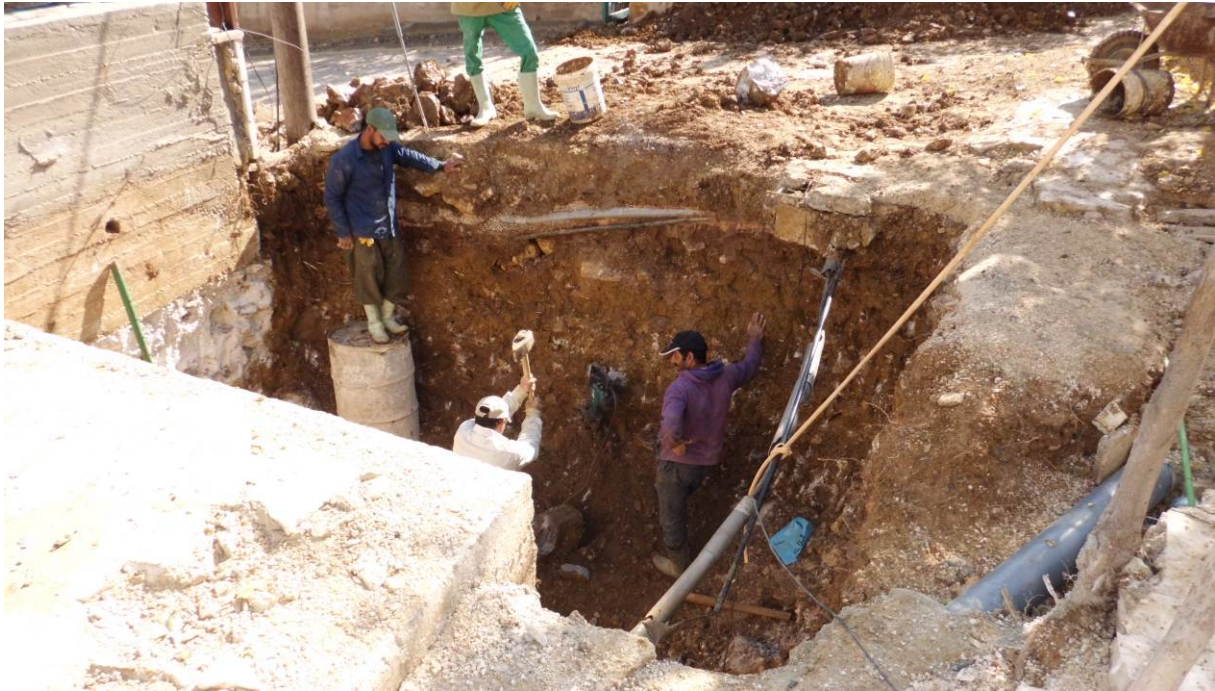
Figure 1: Excavation pit for the Modified Septic Tank

The top soil layers were removed easily but once deeper it took some efforts to dig in the bed rock. Two sewer lines servicing the holding tank had to be diverted in order to proceed with the construction. These lines had to be connected to the Modified Septic Tank during the construction but were not put in operation until the work was finished. The main electric power cable feeding the house was also passing within the excavation area, it was necessary to replace and reroute the cable from the electric pole to the house main distribution board (Electric KWH Meter). For this work it was required to contact the Jordan Electric Power Company so they could bring in their team to connect the new cable to their electric power pole.

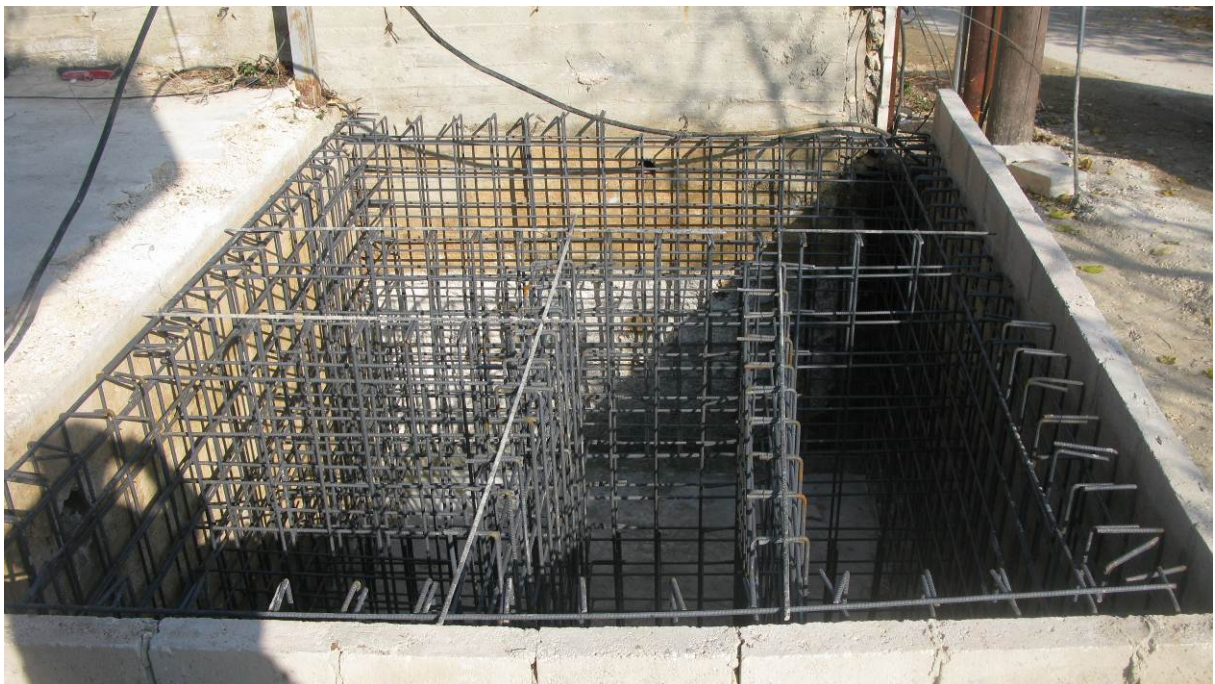
Figure 2: Concrete form and reinforcing steel of the Modified Septic Tank

Considering the fact that the wastewater treatment system had to be installed in a very tight corner, directly adjacent to the parameter wall, to the trees, to the existing septic tank and to the entrance road, it was not possible to provide a comfortable working space for the construction and for the formwork. Once the Excavation completed, concrete blocks were installed as external formworks. Planks were used as internal formwork. The concrete reinforcement was done using reinforcing steel bars.

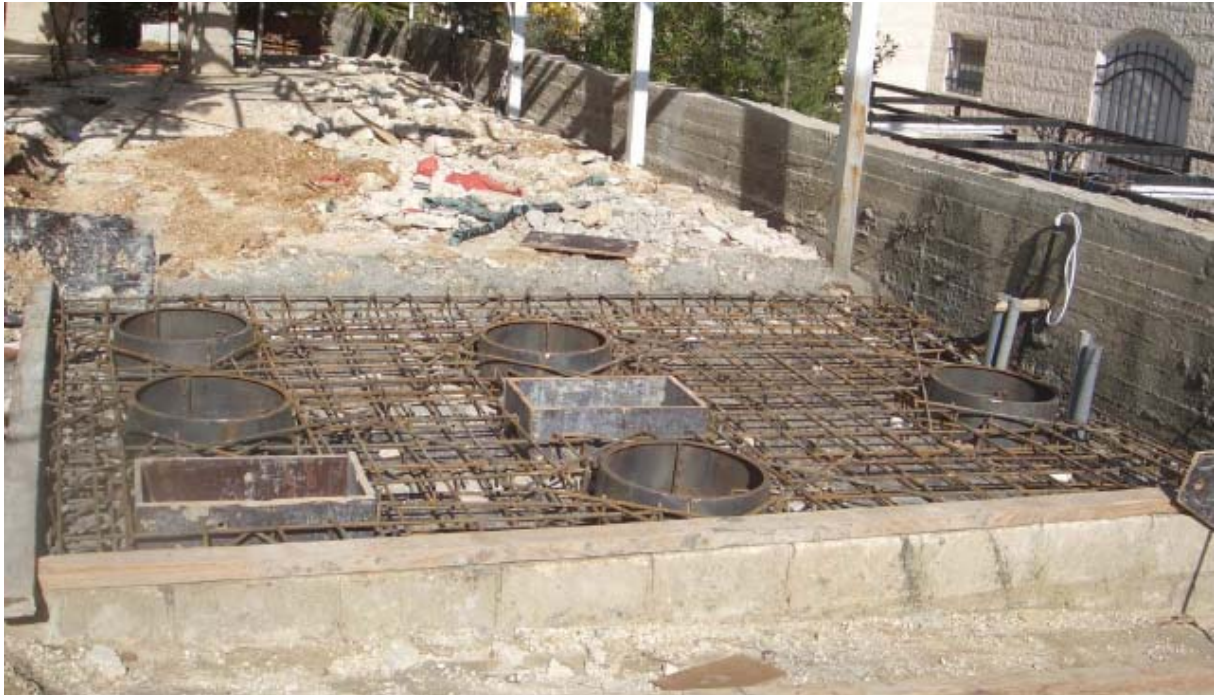
Figure 3: Installation of the manholes and covers.

This operation was done in 3 stages. First the floor concrete slab, then the external and internal walls and finally the roof concrete slab with the openings/block-outs for manholes and covers.

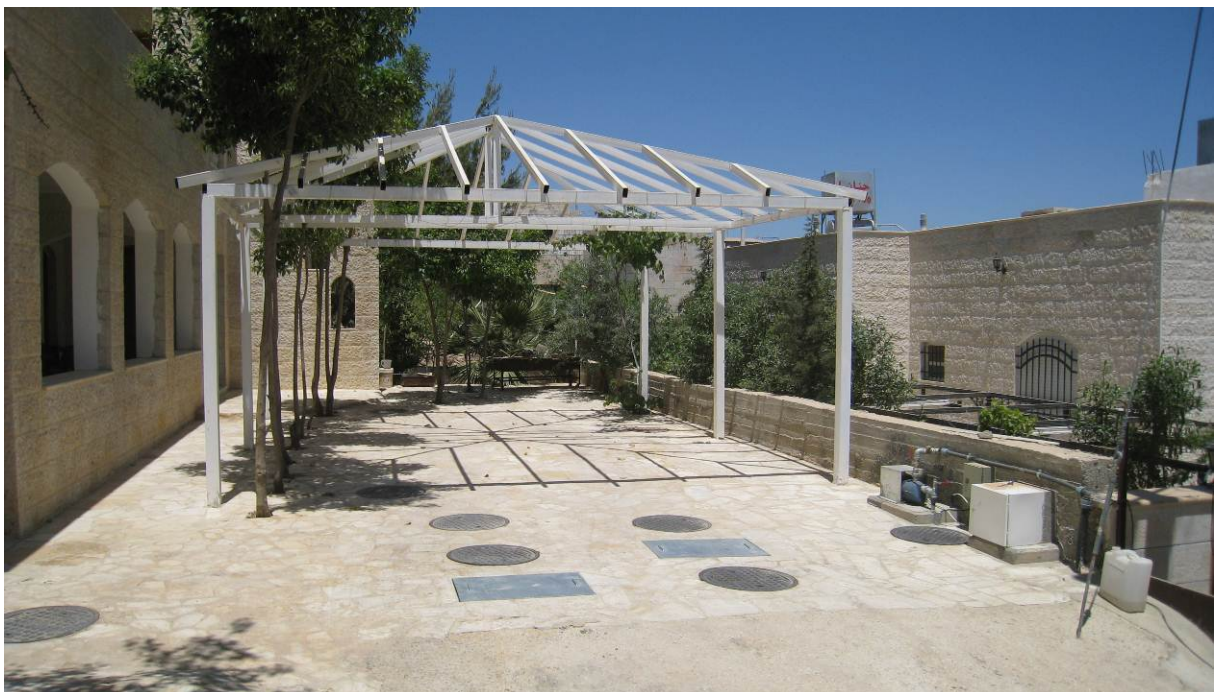
Figure 4: Mr Hiyari's Modified Septic Tank after the end of the construction.

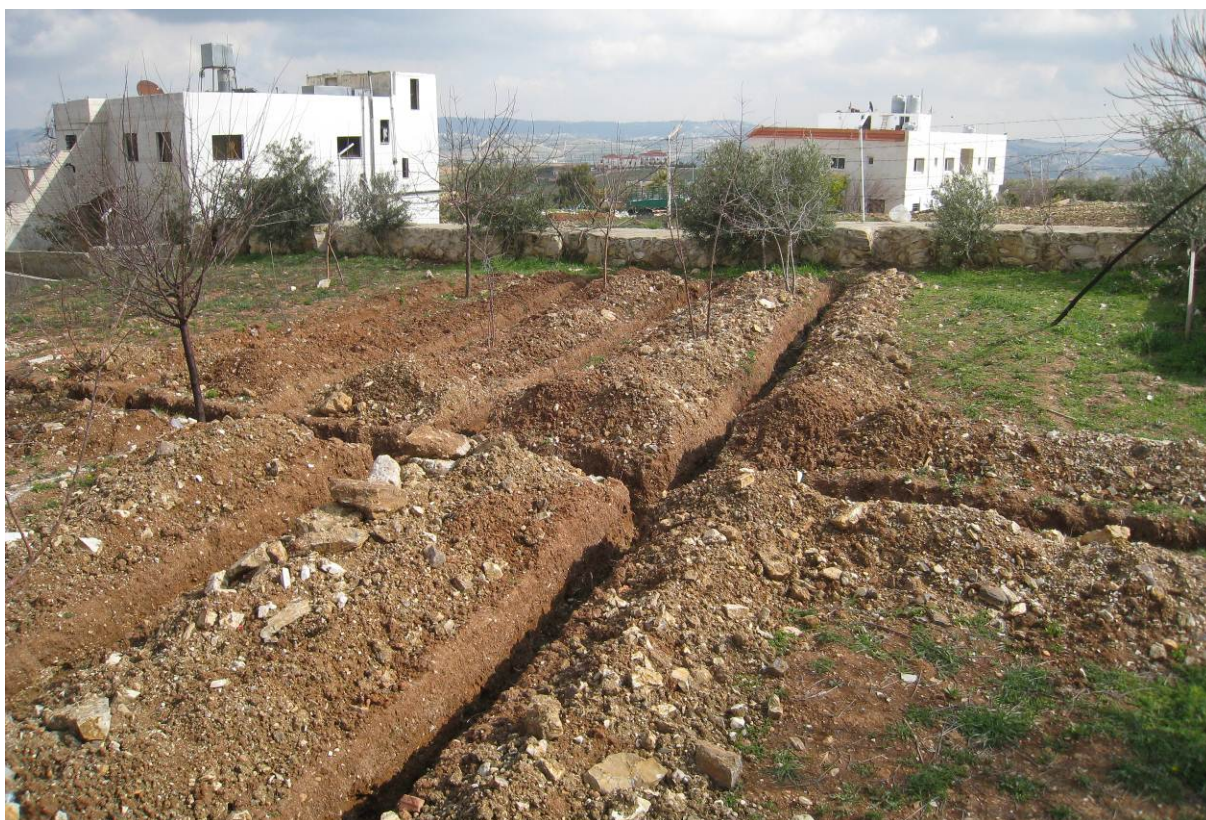
Figure 5: Excavation of the irrigation trenches at Mr Hiyari's house

Again, due to extreme weather conditions, resulting in a muddy and inaccessible site, this part of the work took much longer than originally anticipated. The layout of the site obliged to cross the access road. After the installation and testing of the irrigation lines, the trenches were filled back with the previously excavated soil.

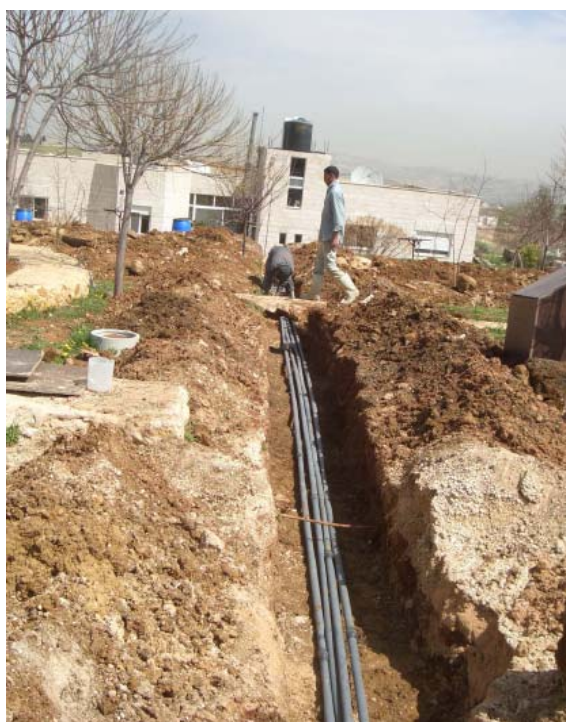
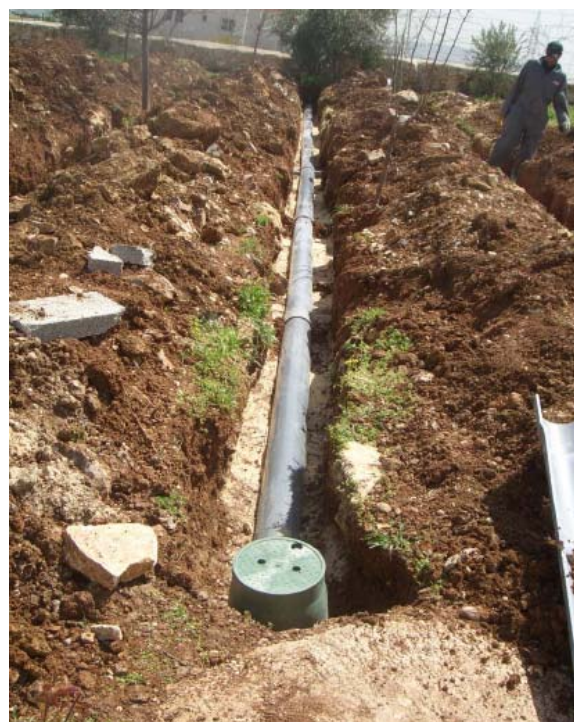
Figure 6: Installation of the irrigation lines in the garden.

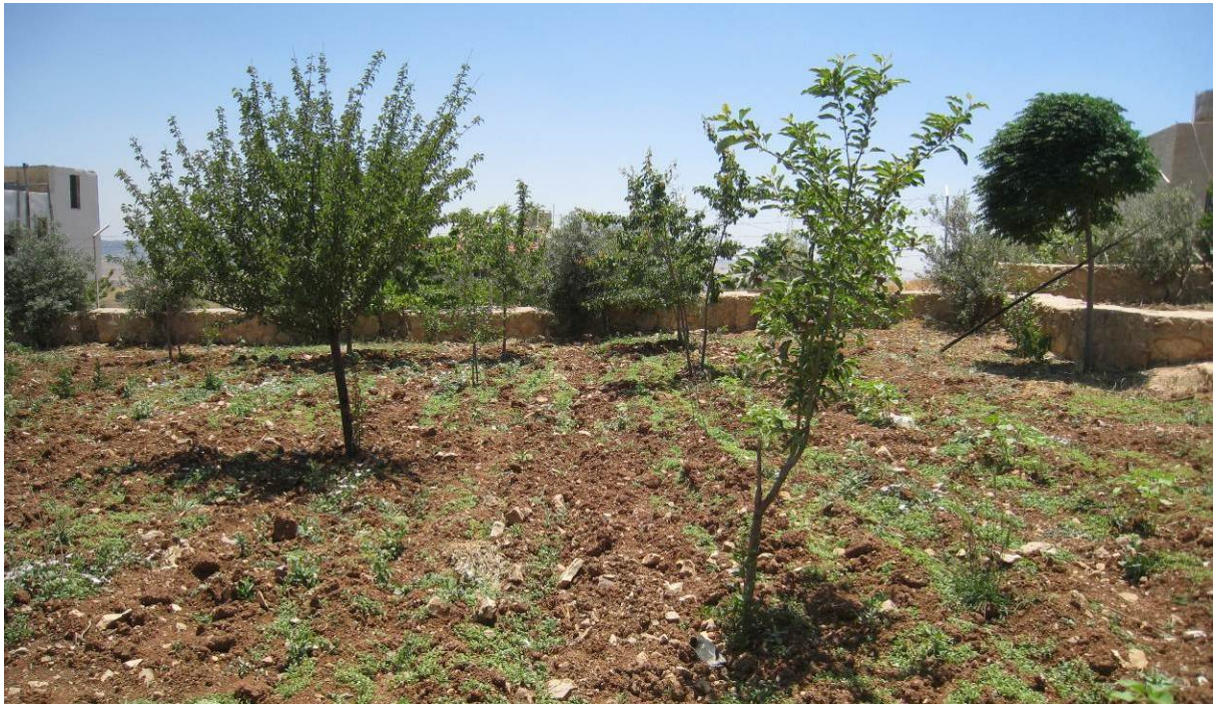
Figure 7: Mr Hiyari's garden after the installation of the irrigation lines.

In order to give the site back in good condition, efforts were made to clean the site and to reconfigure the garden as it was before the construction.

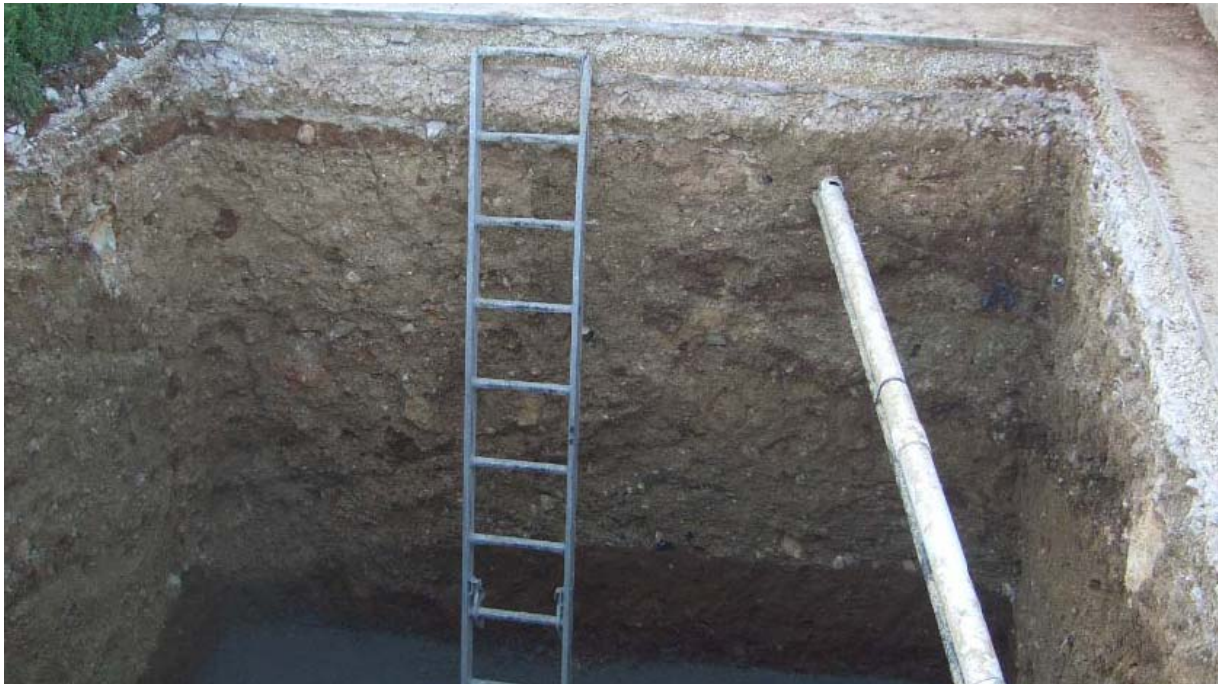
Figure 11: Excavation of the pit for the Modified Septic Tank.

The top soil layers were removed easily but once deeper it took some efforts to dig in the bed rock. The sewer line servicing the septic tank was conserved but the following cesspit was bypassed to reach the Modified Septic Tank. A connection to the cesspit was kept to be used as a backup solution. The main electric power cable feeding the house was also passing within the excavation area. It was necessary to protect the cable through all the construction period. Finally upon completion of the construction work, a new sleeve/conduit was installed to protect the cable.

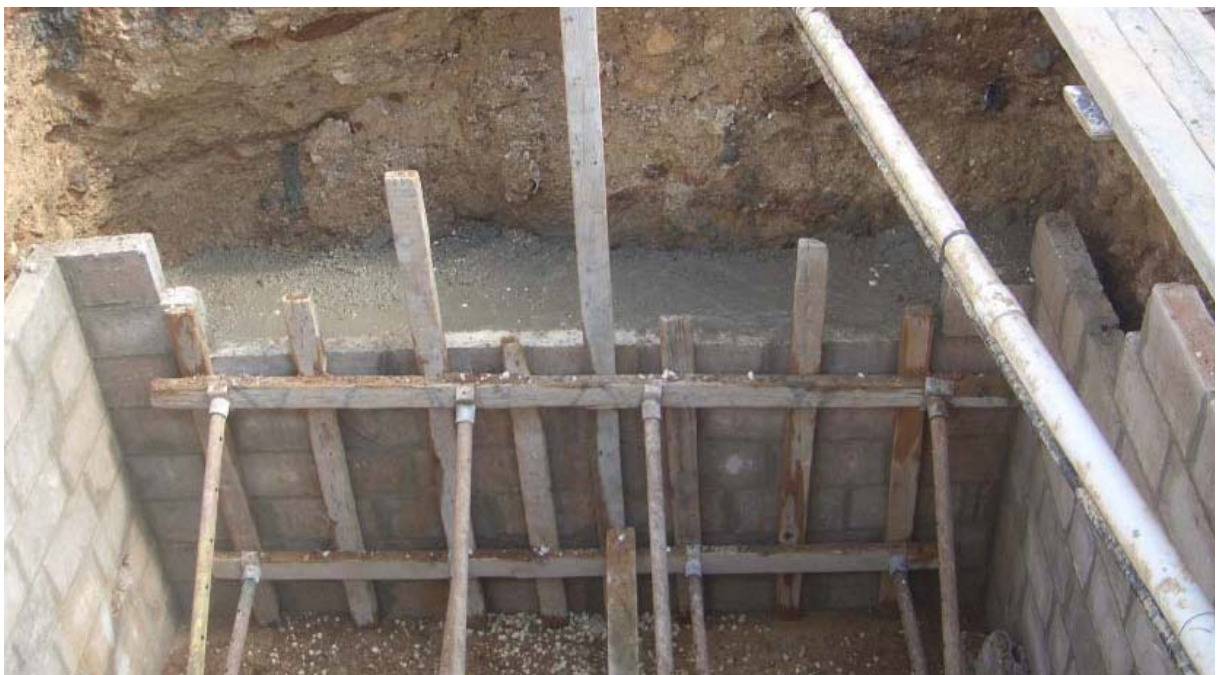
Figure 12: Reparation of the wall collapse.

As mentioned before, the bad weather conditions (rain) rendered the construction of the system difficult by muddying the site and weakening the excavation hole. In the main excavation pit, a wall collapsed during the night of the 2<sup>nd</sup> of April, before the concrete form and the reinforcements could be installed. This accident did not endanger the workers but delayed the work by a few days.

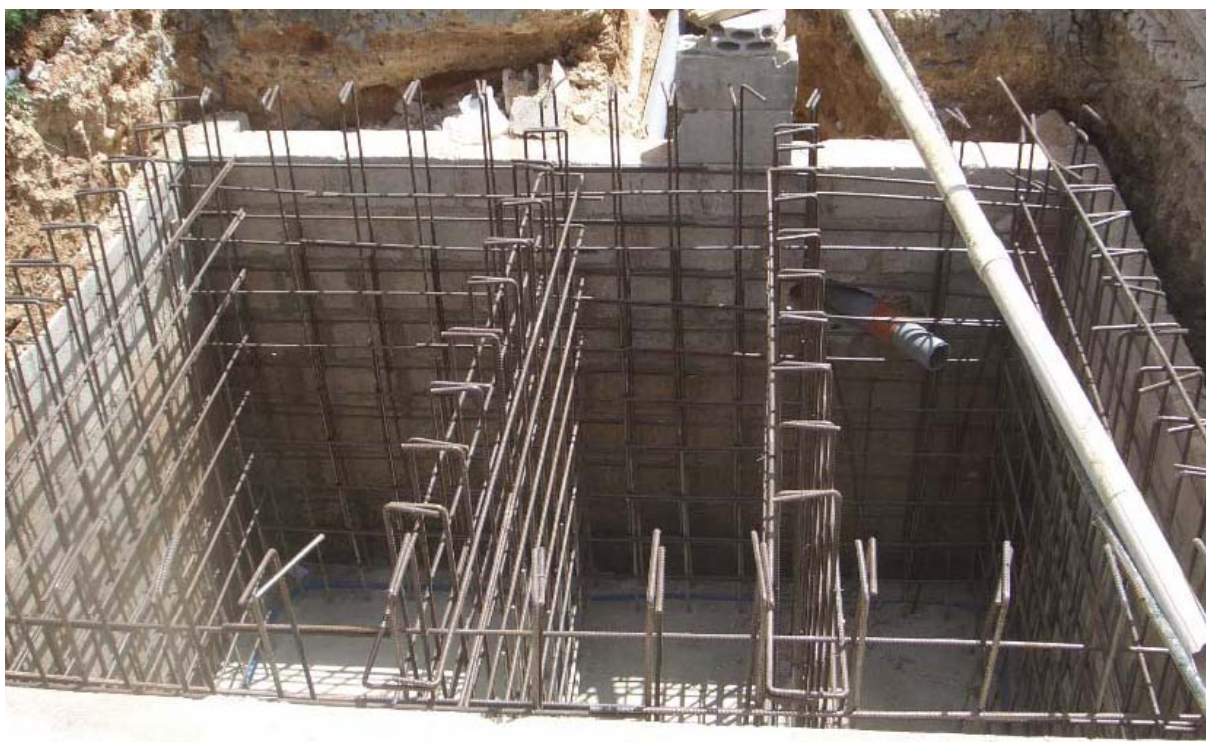
Figure 13: Concrete walls and reinforcing steel of the Modified Septic Tank.

As the wastewater treatment system had to be installed in a very tight corner directly adjacent to the Parameter wall, to the trees, to the existing septic tank and to the entrance road, it was not possible to provide a comfortable working space for the construction and for installing the formwork. Once the excavation completed, concrete blocks were installed as external formwork in order to limit the space requirements and thus the excavation work. Planks were used as internal forms. The concrete reinforcement was done using reinforcing steel bars.

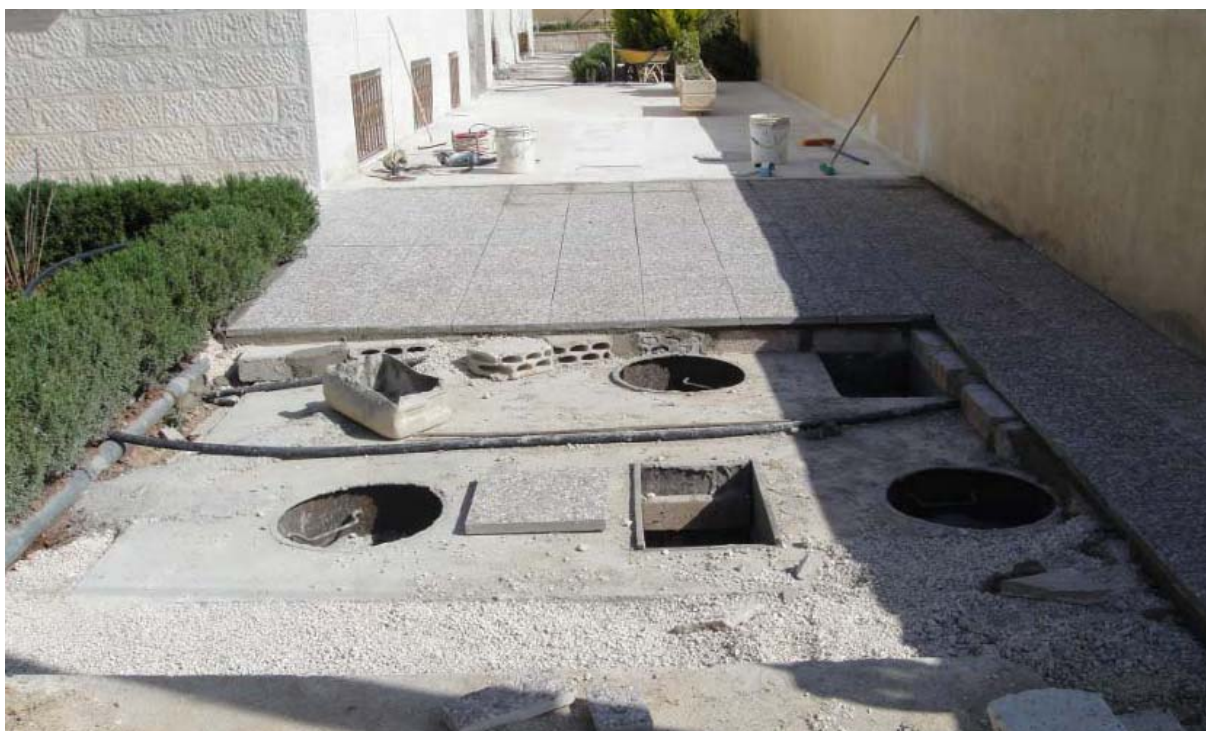
Figure 14: Reinstalment of the tiles.

It was necessary to run the irrigation lines under the existing tiled walkways and then reinstate these walkways back to original condition. Moreover the garden was nicely planted and the irrigation lines were running between plants and trees. Works were thus executed very carefully in order to prevent damage to the existing vegetation. This work was realised without any complaint from the house owner. In order to give the site back in good condition, efforts were made to clean the site and to reconfigure the garden as it was before the construction.

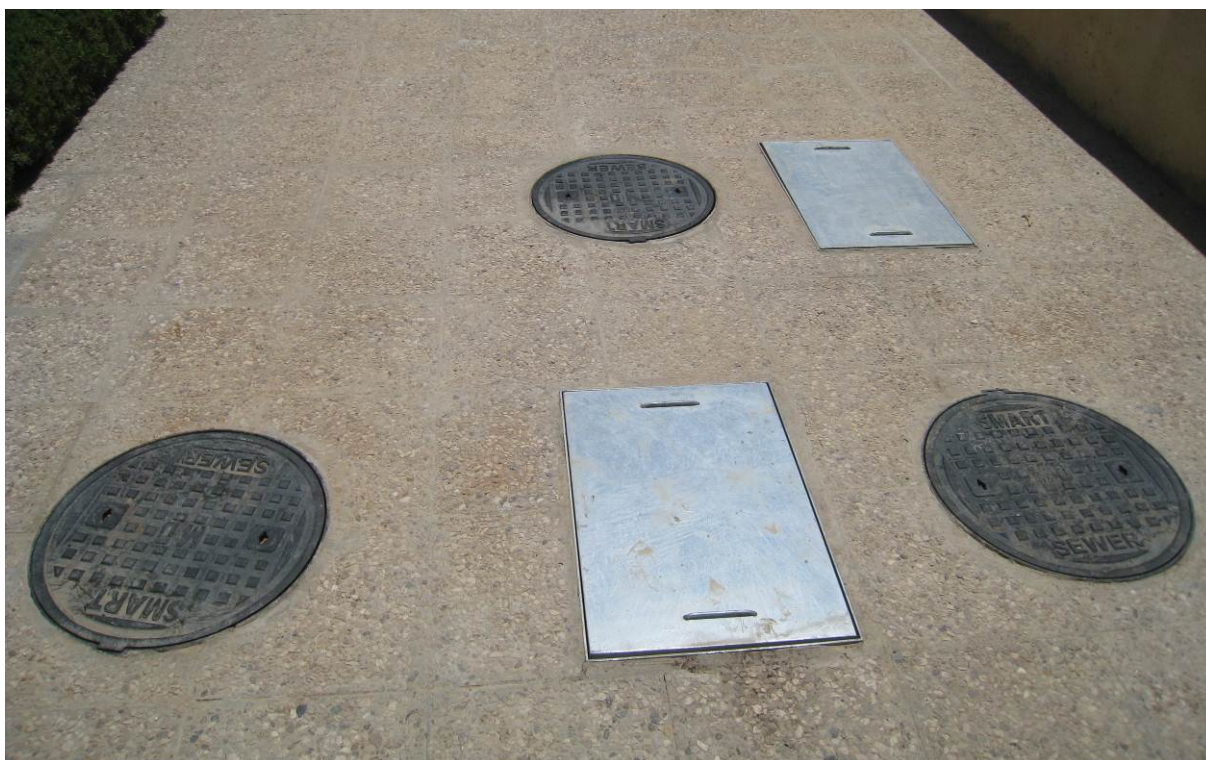
Figure 15: Mr Shehabi's Modified Septic Tank after the end of the construction.

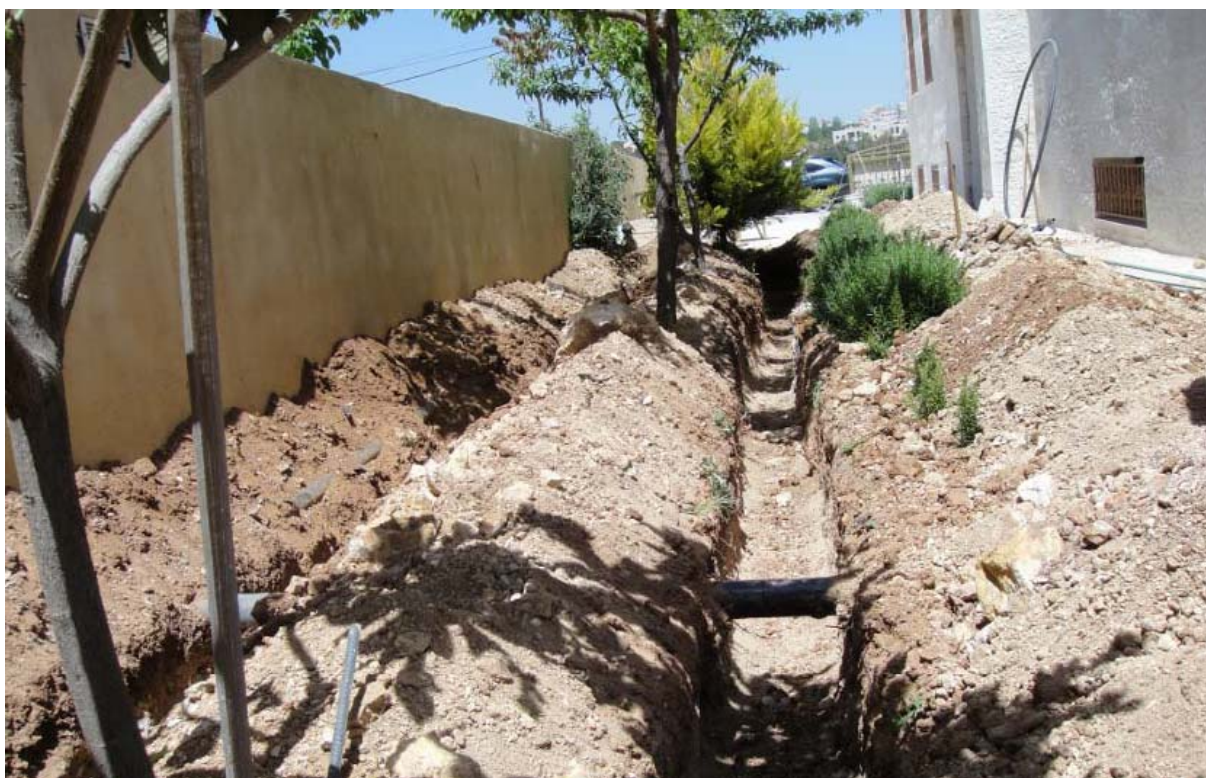
Figure 16: Excavation of the irrigation trenches.

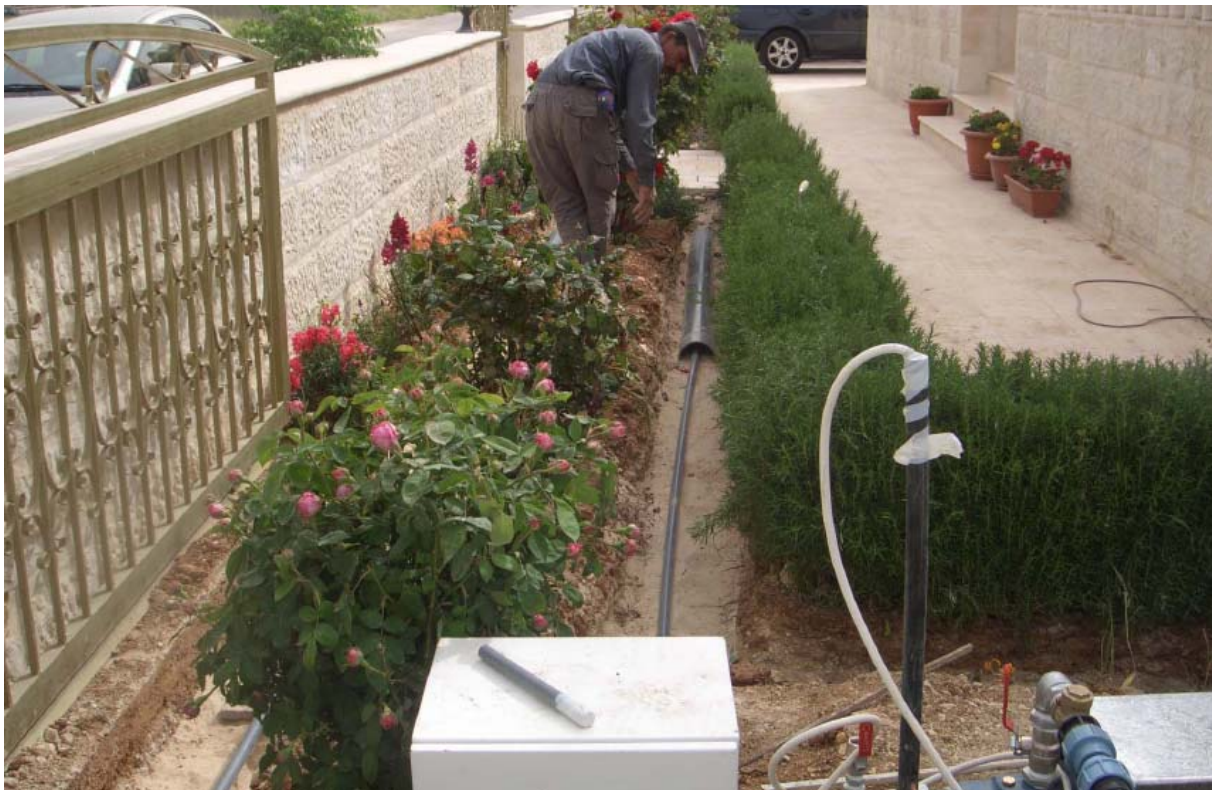
Figure 17: Installation of the irrigation lines in the front yard.

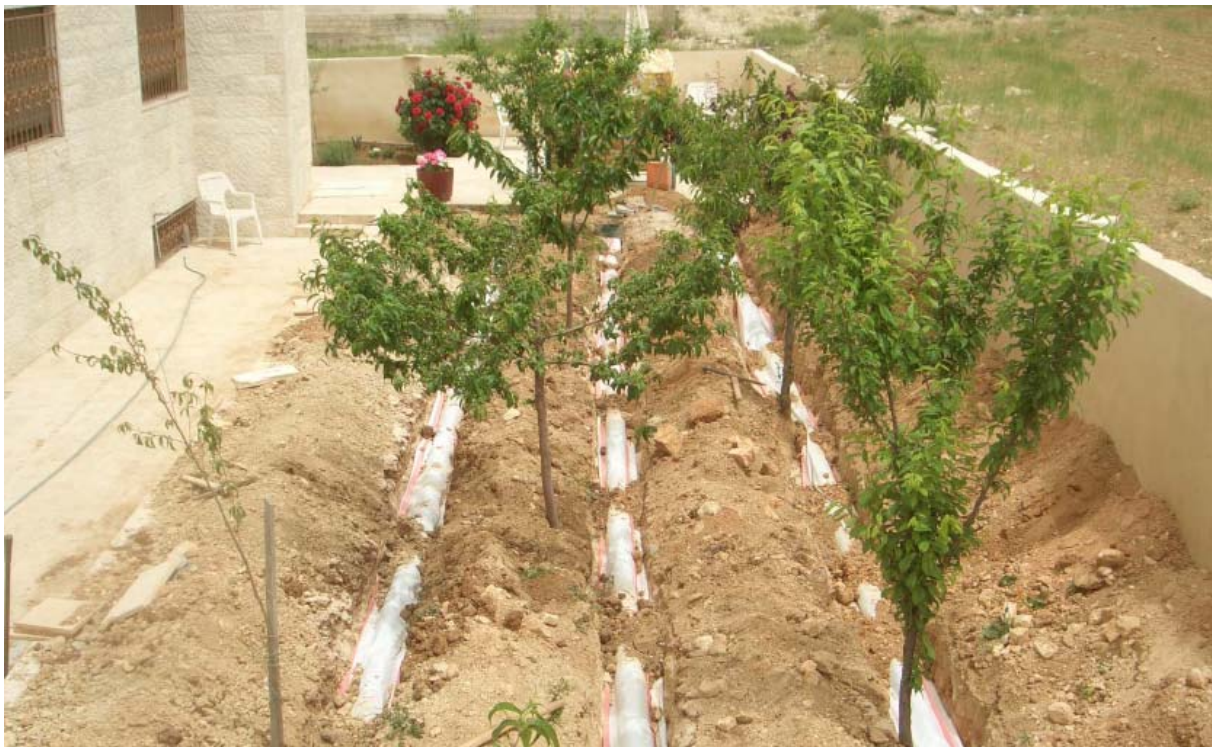
Figure 18: Installation of the irrigation lines in the back yard.

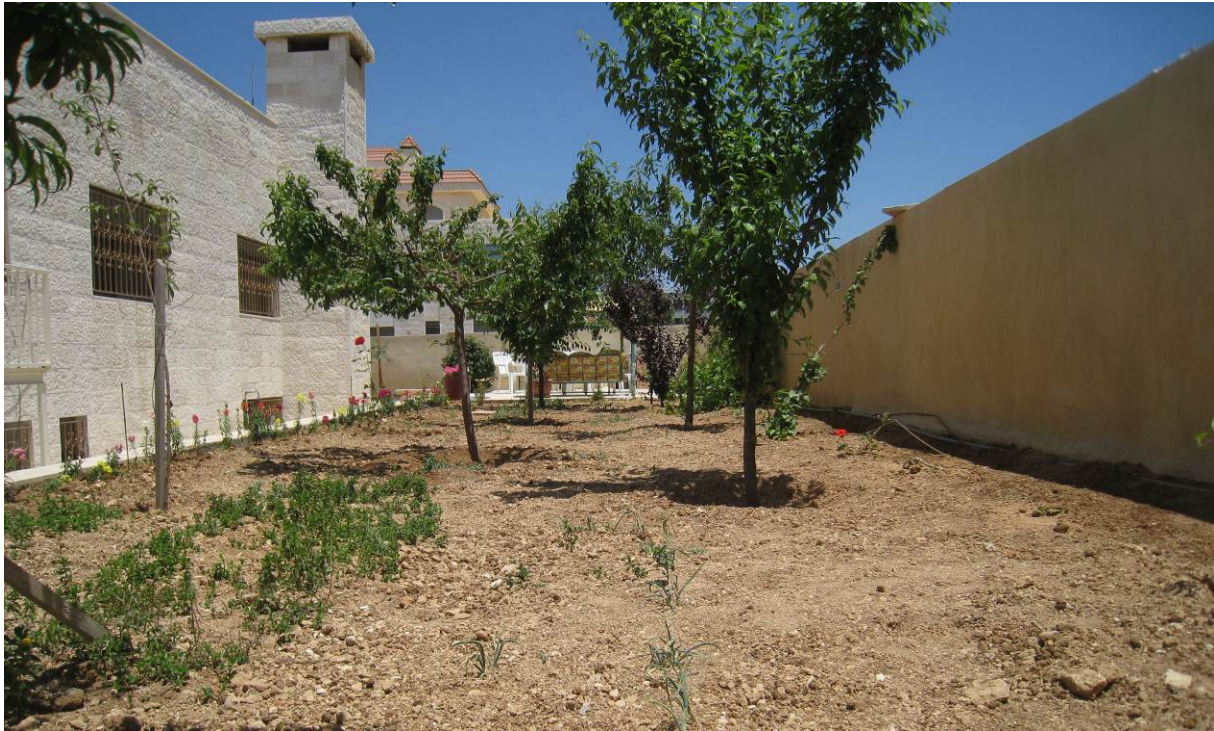
Figure 19 Mr Shehabi' garden after the installation of the irrigation lines.

The existing garden was very well maintained and great care had to be given to the installation of the irrigation lines to avoid damage to the vegetation.

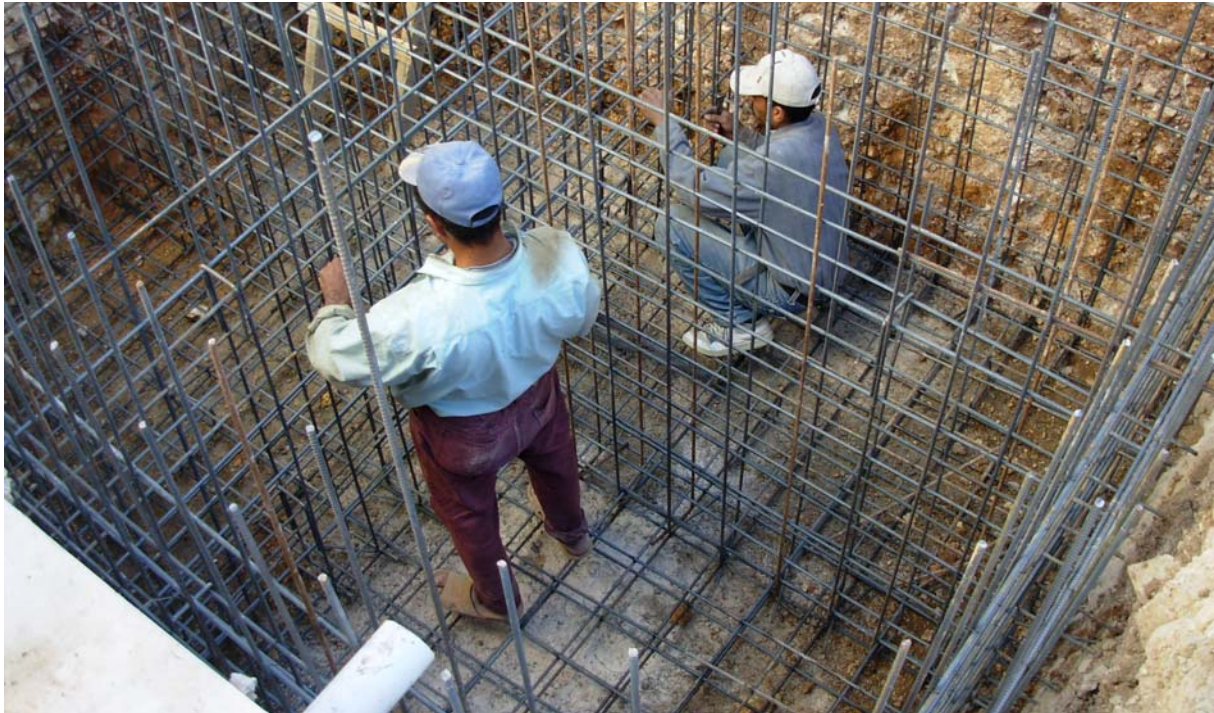
Figure 23: Installation of the reinforcement steel for the Modified Septic Tank.

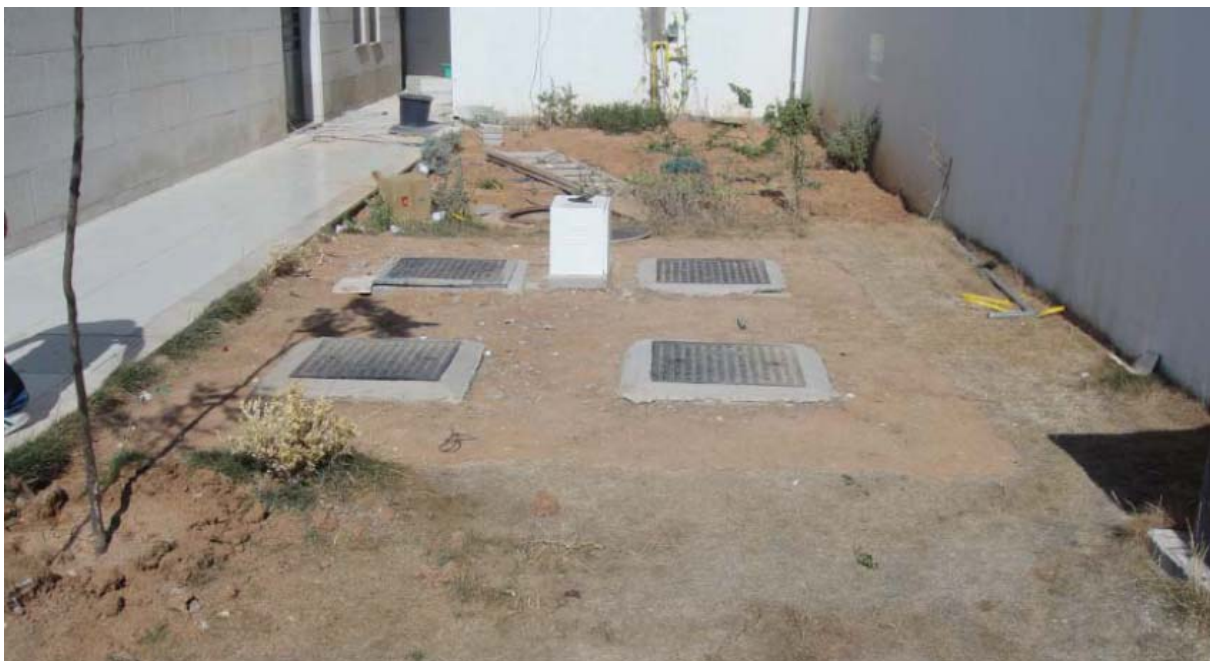
Figure 24: The Modified Septic Tank at the end of the construction.

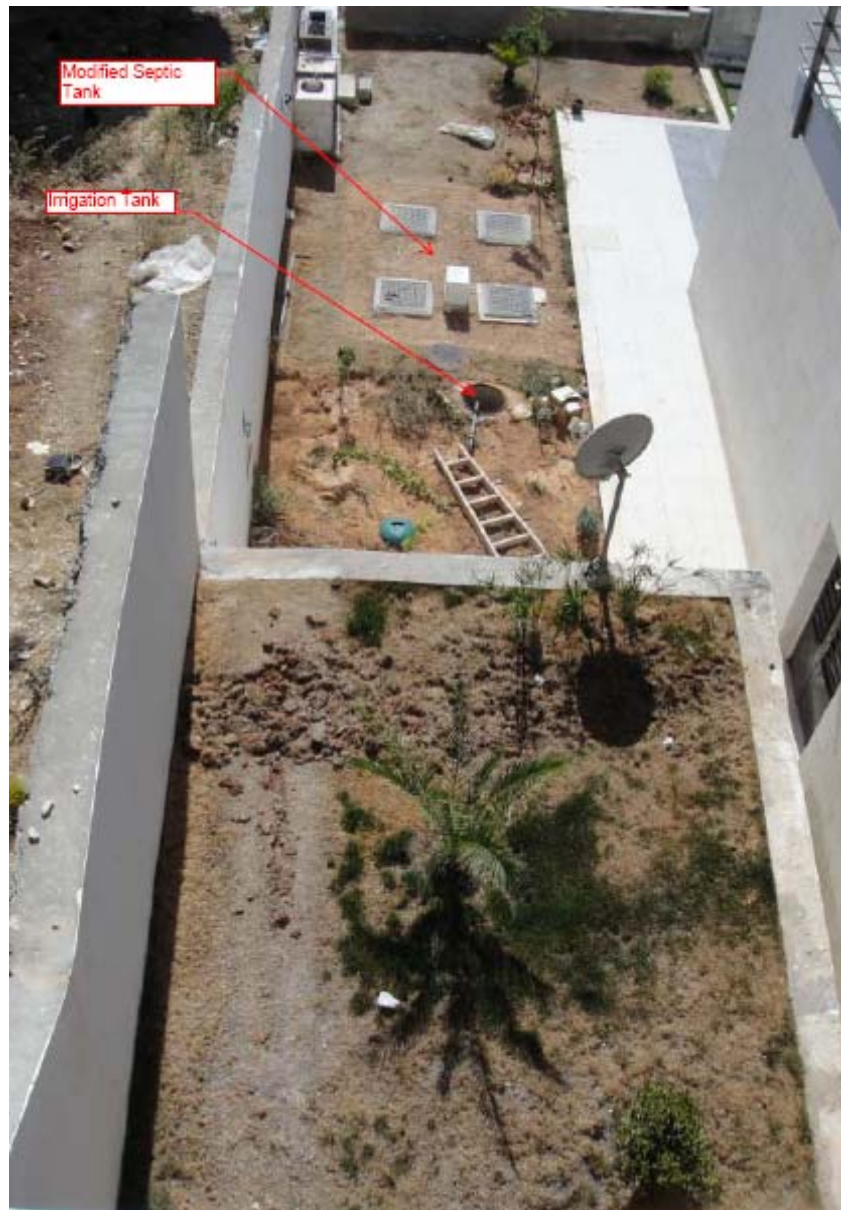
Figure 25: The Modified Septic Tank in Mr Akeel's garden.

In order to give the site back in good condition, efforts were made to clean the site. Lawn was also installed on top of the tanks to provide some landscape integration.

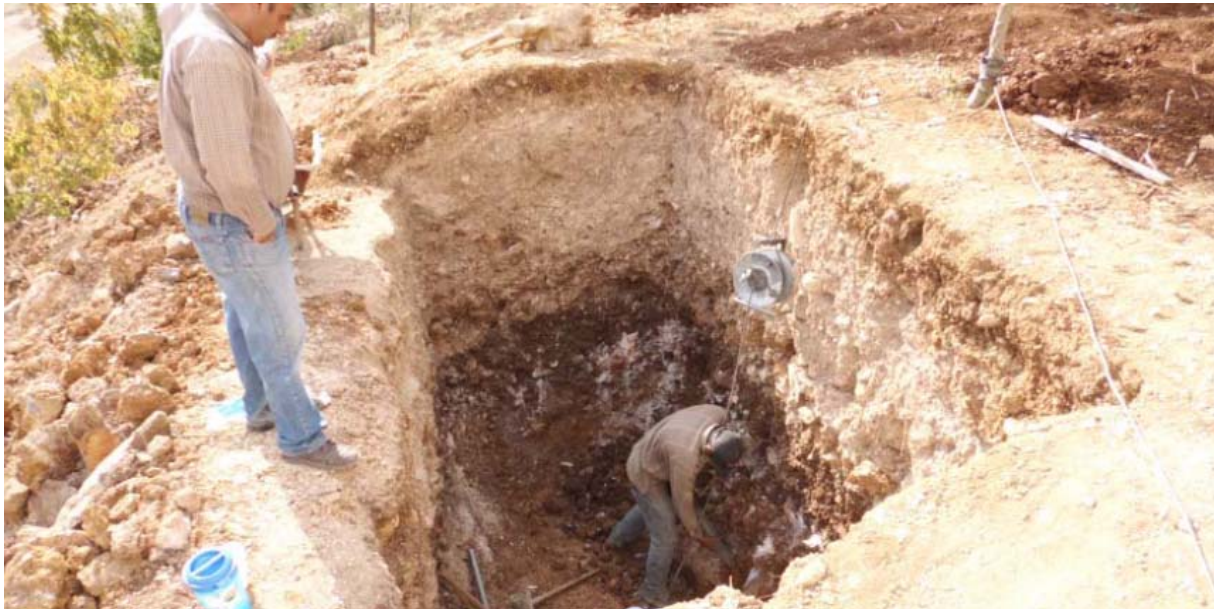
Figure 29: Excavation of the septic tank.

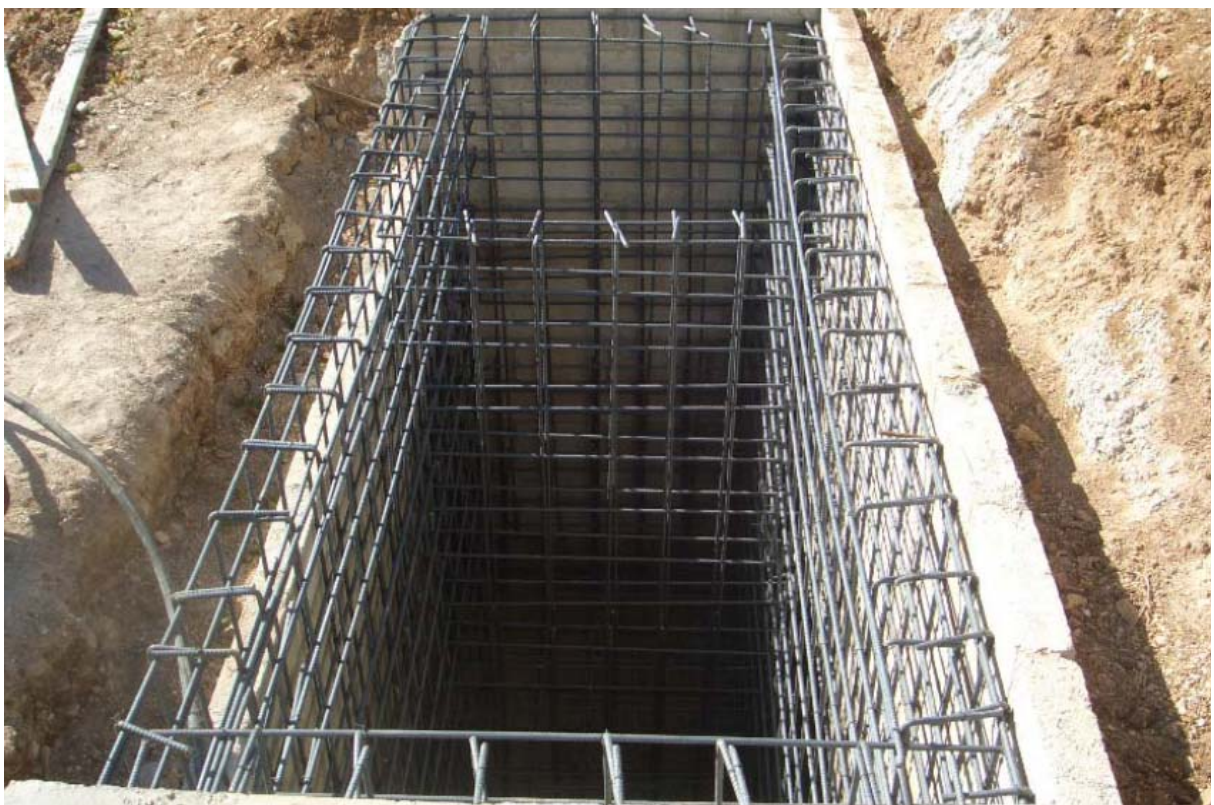
Figure 30: Concrete form and reinforcing steel of the septic tank.

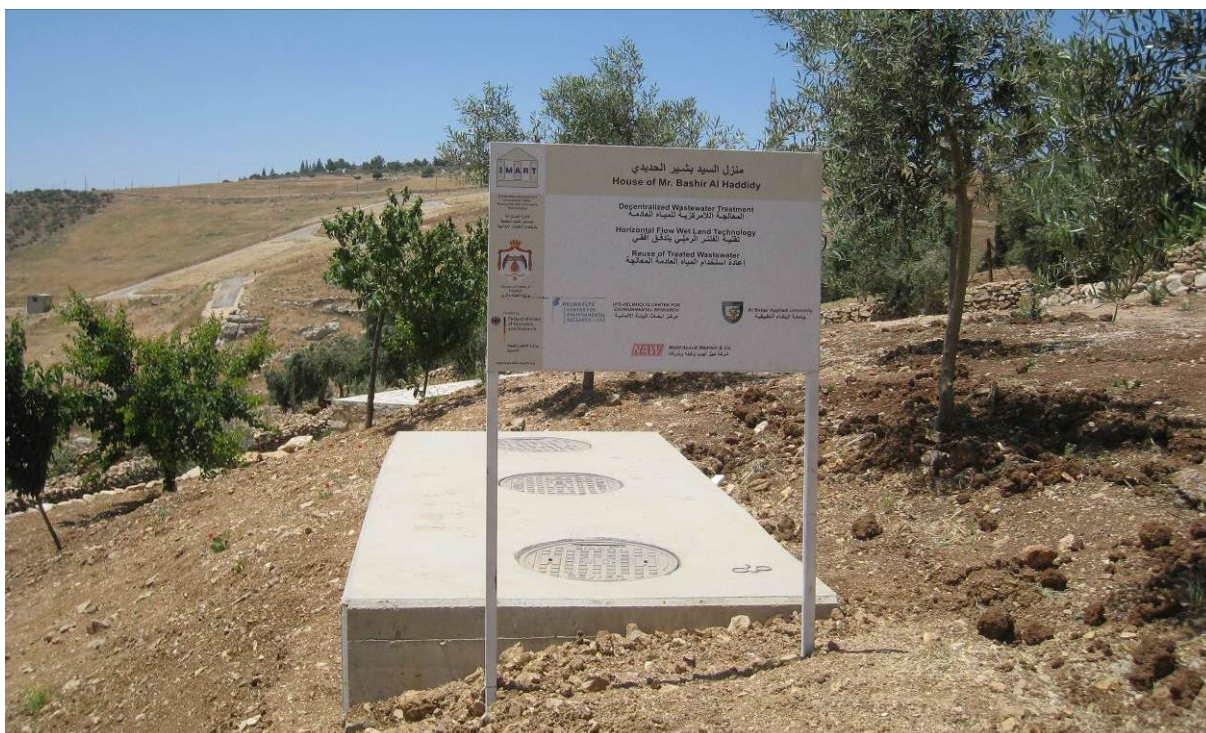
Figure 31: The septic tank after completion.

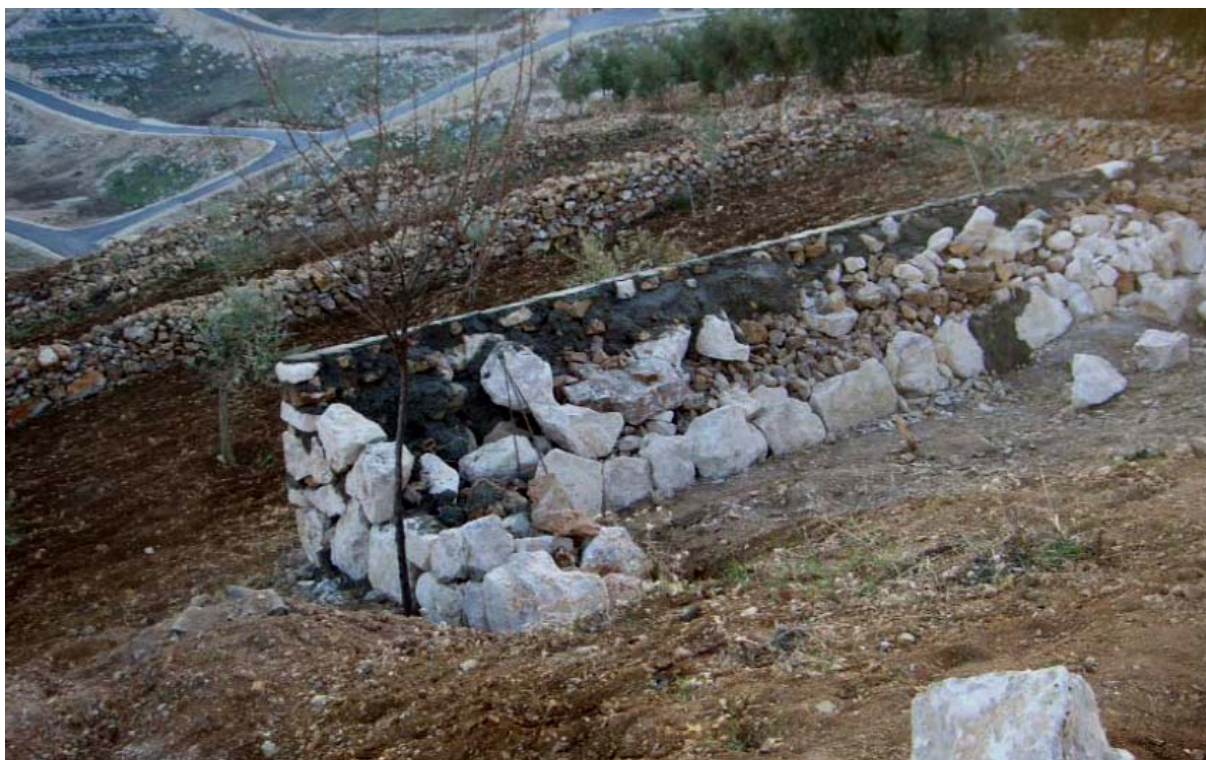
Figure 32: construction of the retaining walls before the installation of the wetland.

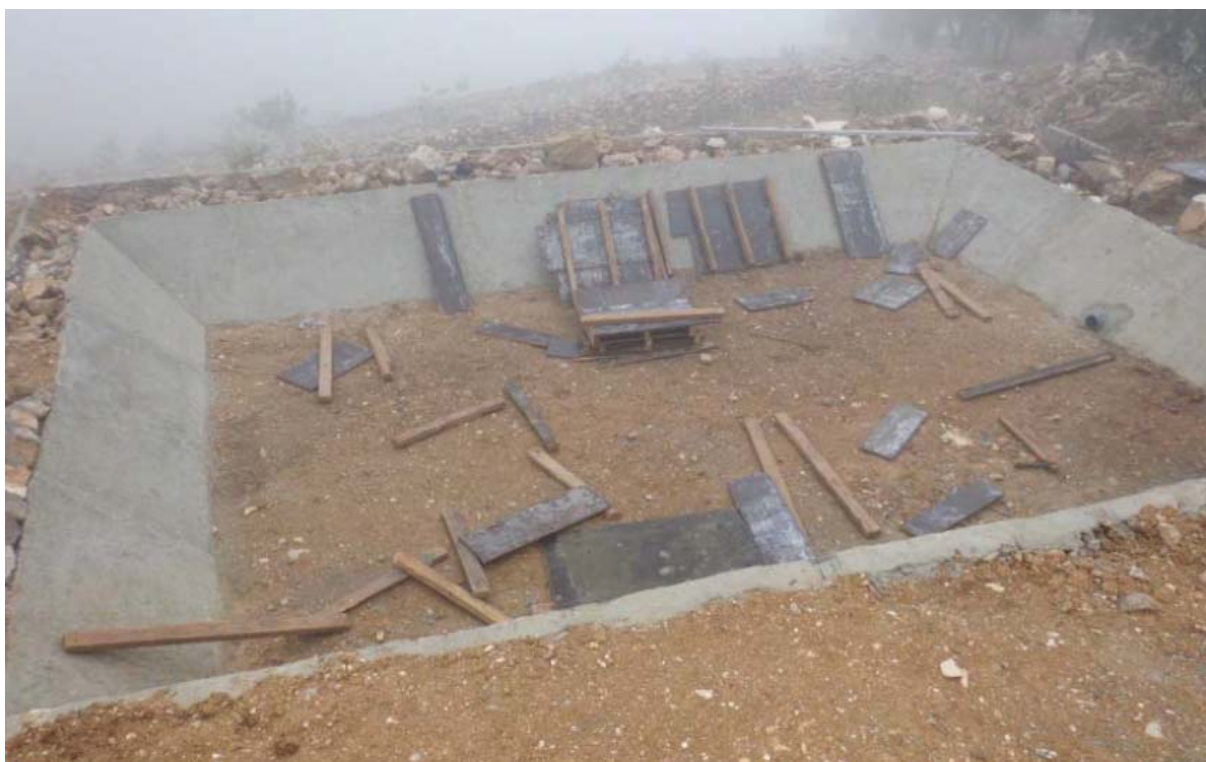
Figure 33: Construction of the wetland.
