# **SMART 2 – IWRM**

### **Decentralised wastewater treatment and reuse:**

**Report on the Construction of Modified Septic Tanks  
and Treatment Wetlands**

**September 2012**

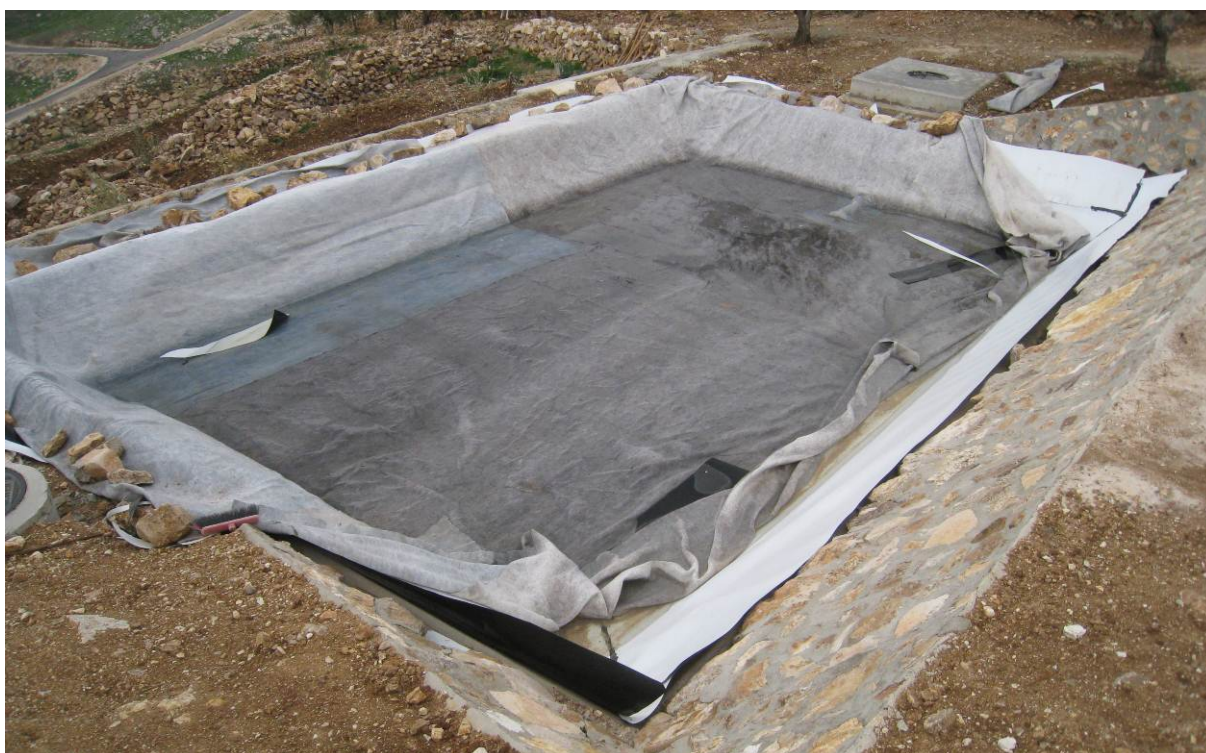
Figure 34: Installation of the liner and geotextile in the wetland.

In wetlands, the sealing of the bed is a crucial operation in order to ensure that no partially or untreated wastewater infiltrated the ground. The sealing requires the installation of a liner but before that stones that may puncture the liner have to be removed and a small layer of sand applied. The liner is then installed with great attention paid to the sealing of the joints. Another layer of geotextile is added on top of the liner to prevent direct contact of the media with the liner and prevent direct exposure of the liner overboard to the sun. Installing liner and geotextile took about

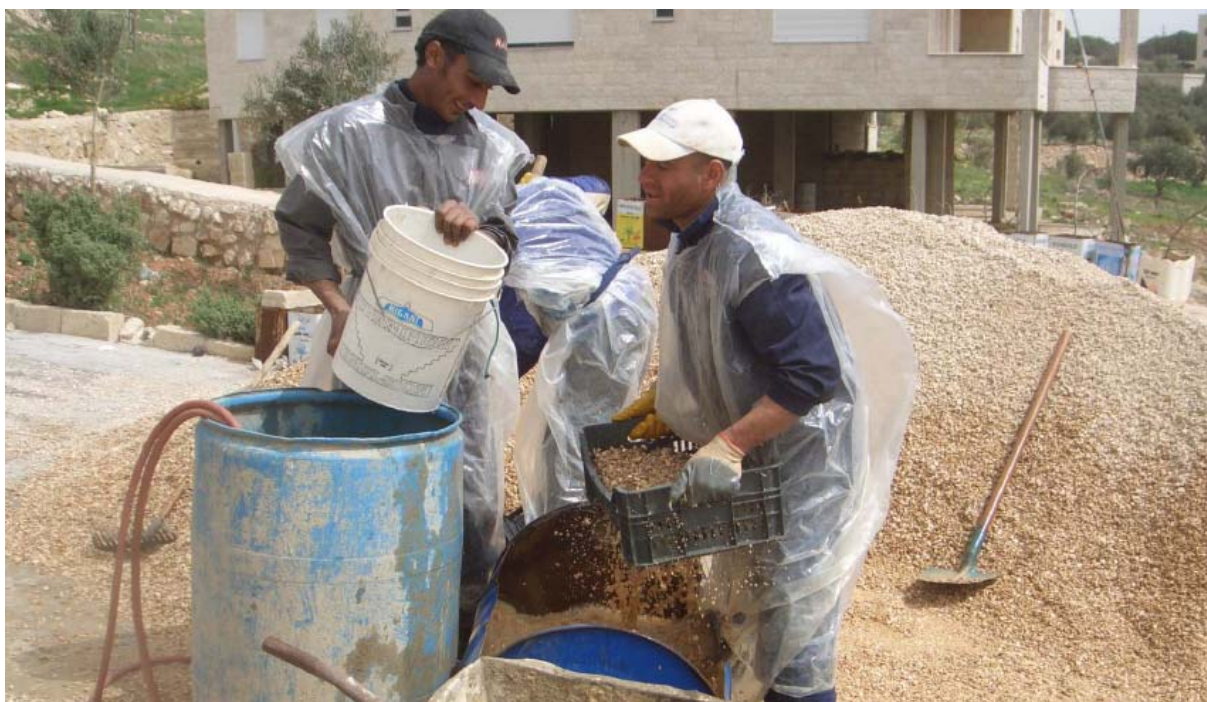
Figure 35: Preparation (cleaning) of the wetland's filter media.

Finding appropriate filter media for the wetland was a difficult task. The wadi stones that fitted the quality criteria have been found in the Jordan valley. However, once collected and brought onsite, they had to be washed to remove fines that could have settled at the bottom of the bed and clogged the pipework.

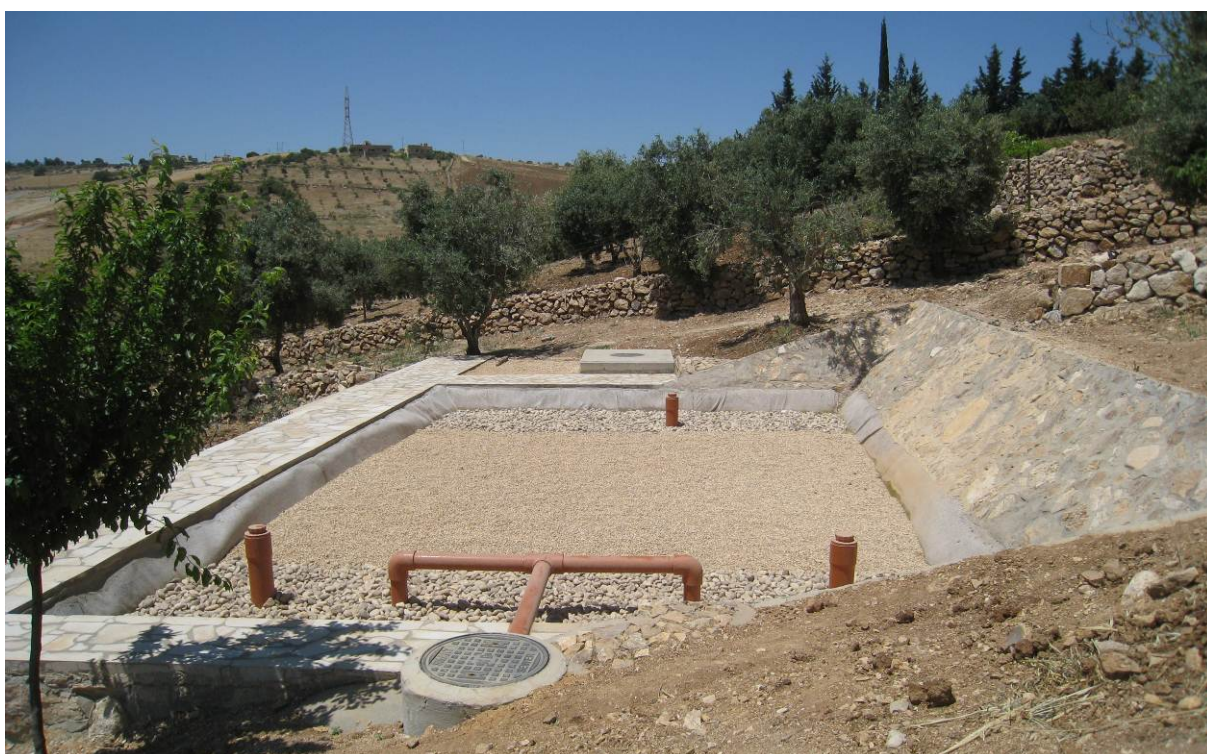
Figure 36: The wetland after completion.

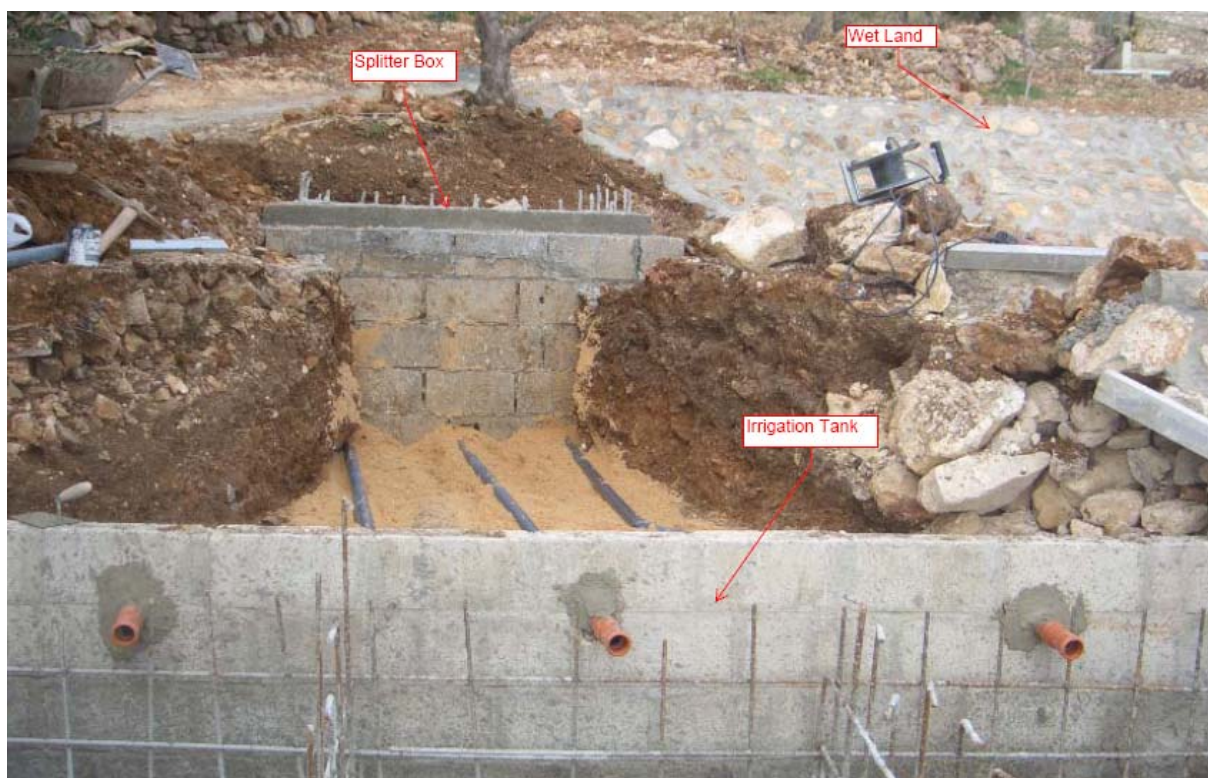
Figure 37: Concrete walls and reinforcing steel of the flow splitting box and irrigation tanks.

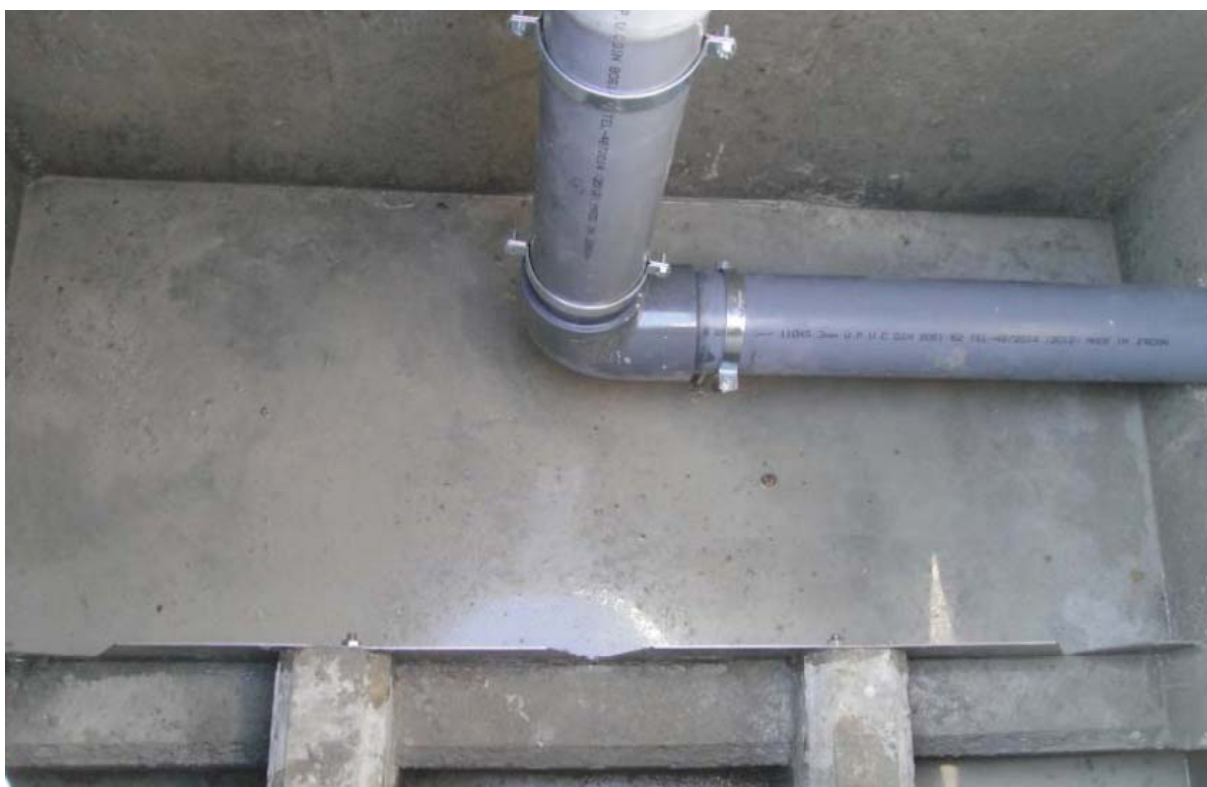
Figure 38: Interior of the flow splitting box.

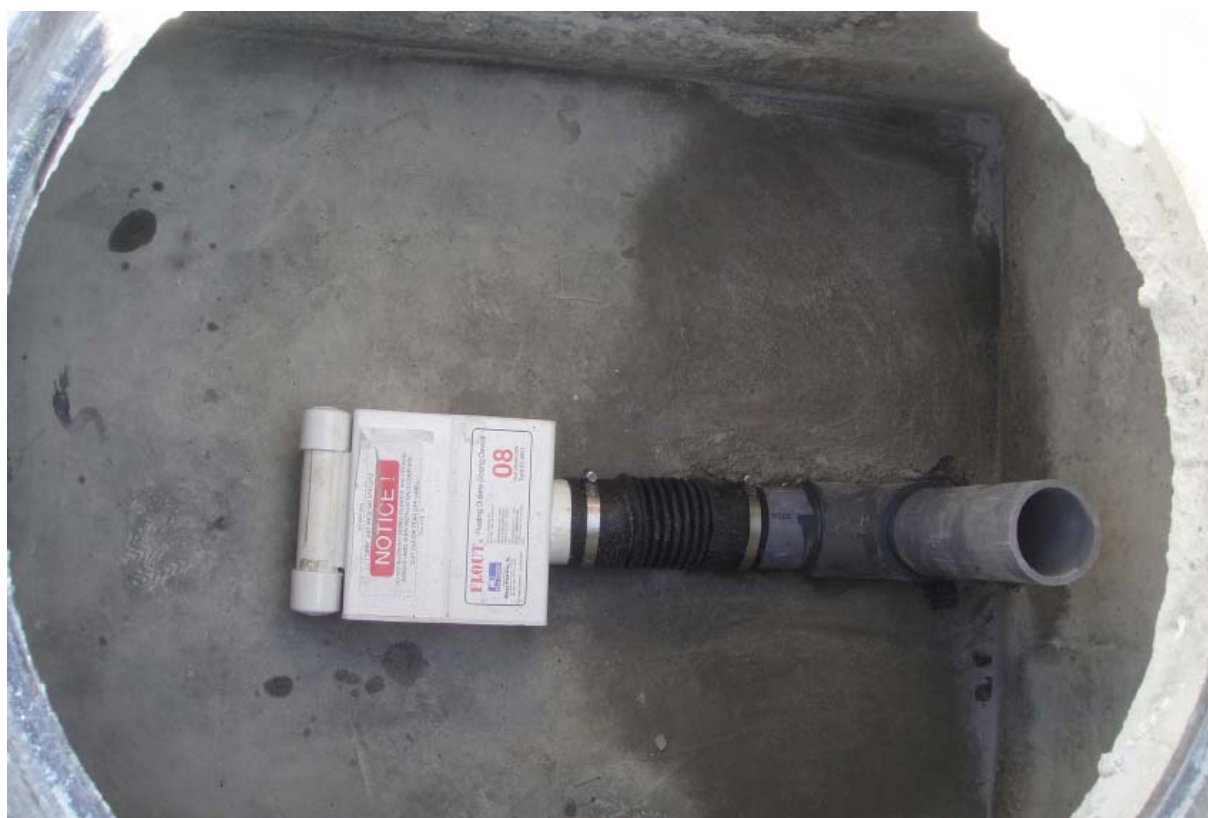
Figure 39: Flow dosing device (flout) for the irrigation fields.

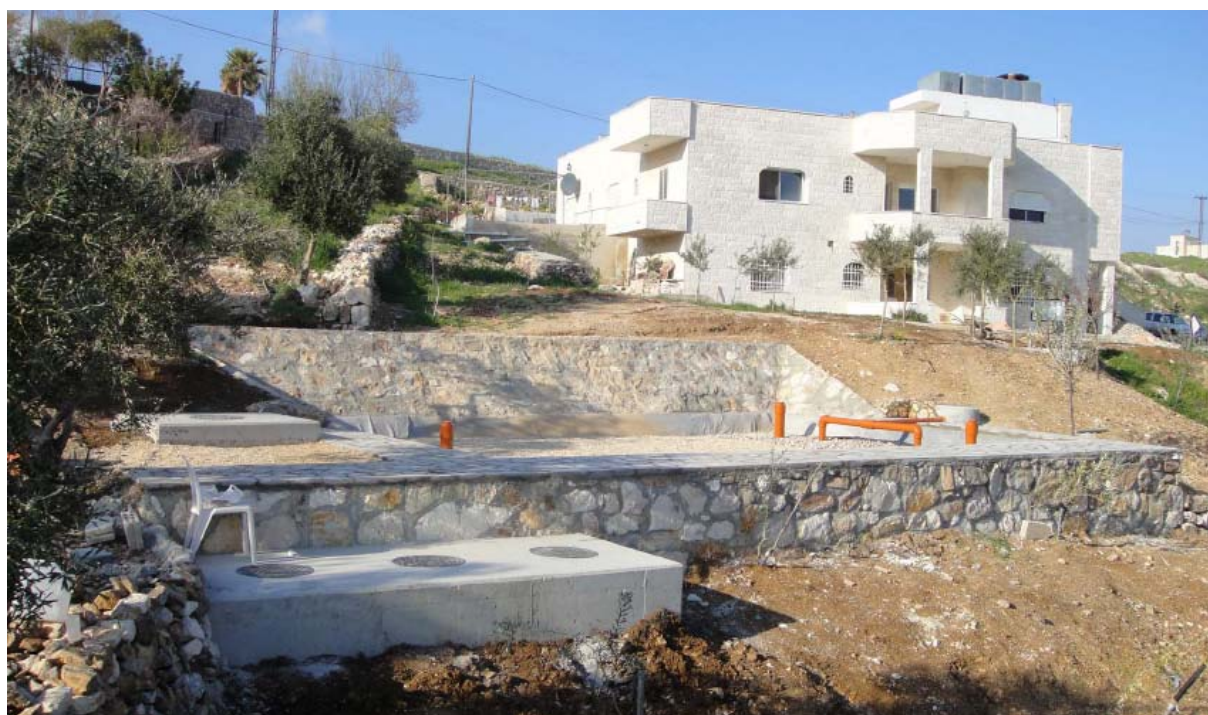
Figure 40: Mr Hadidy's wetland, flow splitting box and irrigation tank after completion.

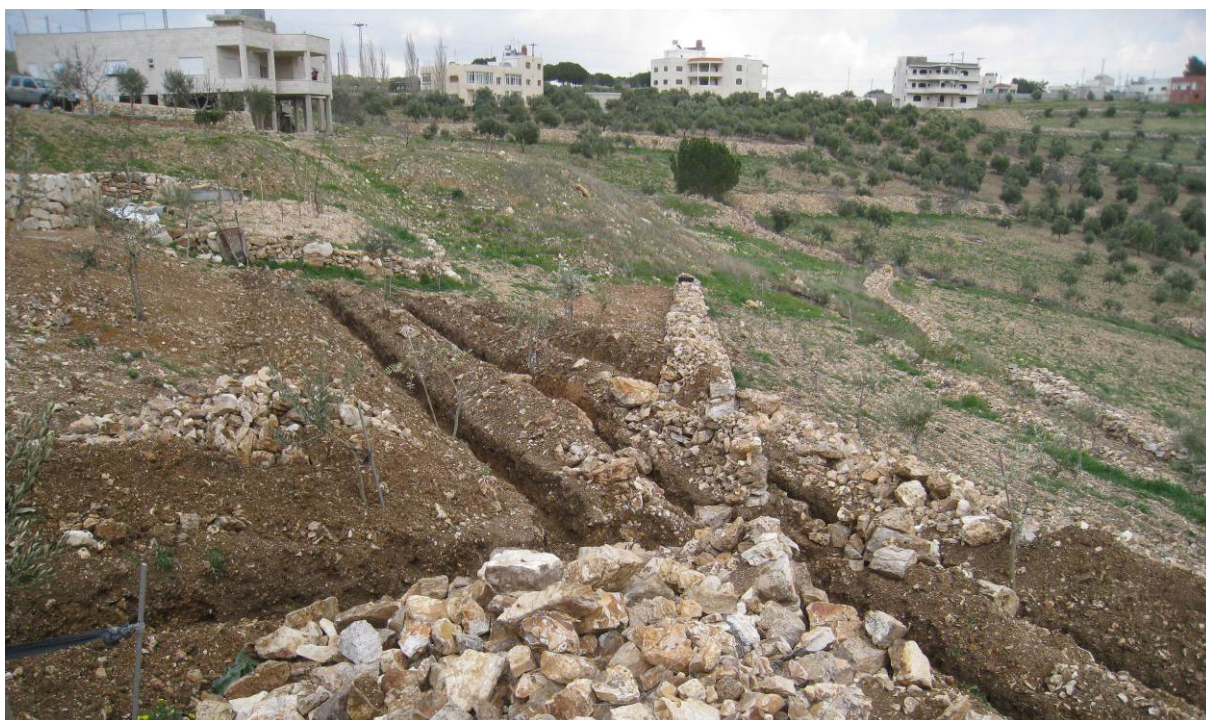
Figure 41: Excavation of the irrigation lines.

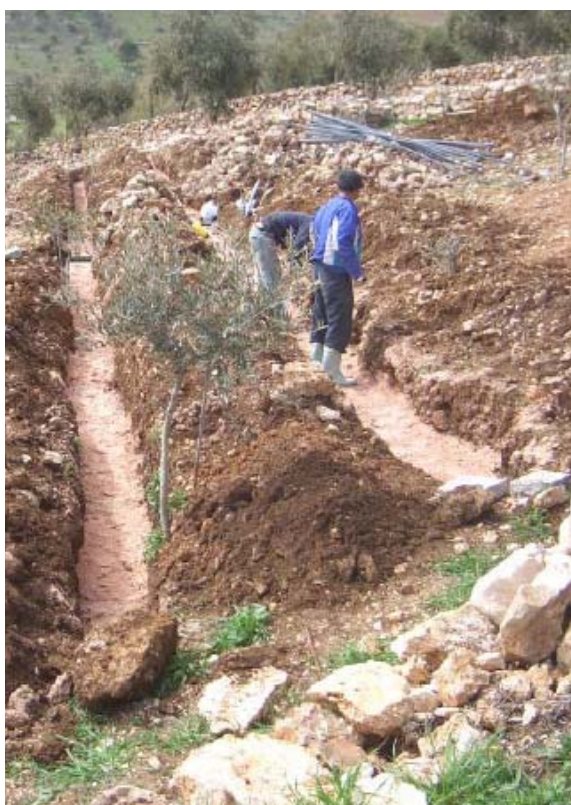
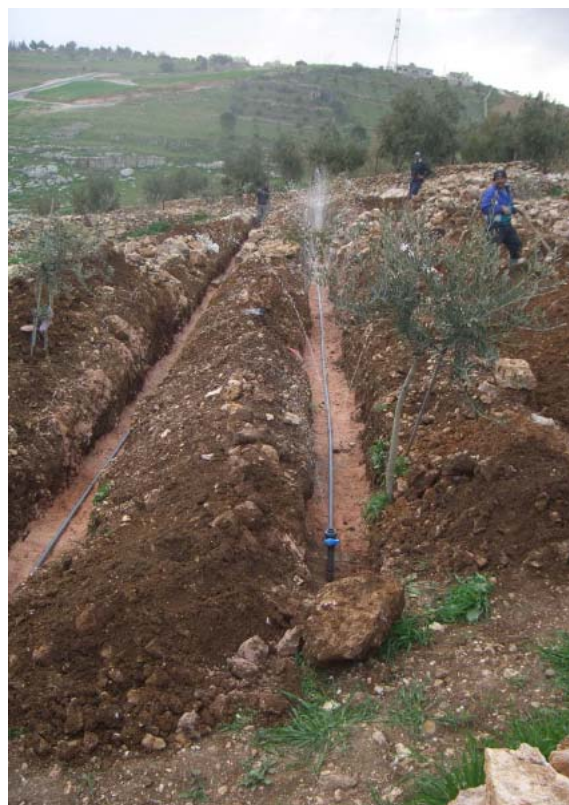
Figure 42: Installation and water testing of the irrigation lines.
