Work package 3, Deliverable D 304 and 307

**Deliverable 304: Report Construction of the  
SBR-WWT&R system and SBR on- site –WWT&R  
Systems**

**Deliverable 307: Remote control systems for  
WWT&R units to detect and inform maintenance  
Personnel about system failure and  
preventive information**

**Thomas Gester, ATB Umwelttechnologien GmbH**

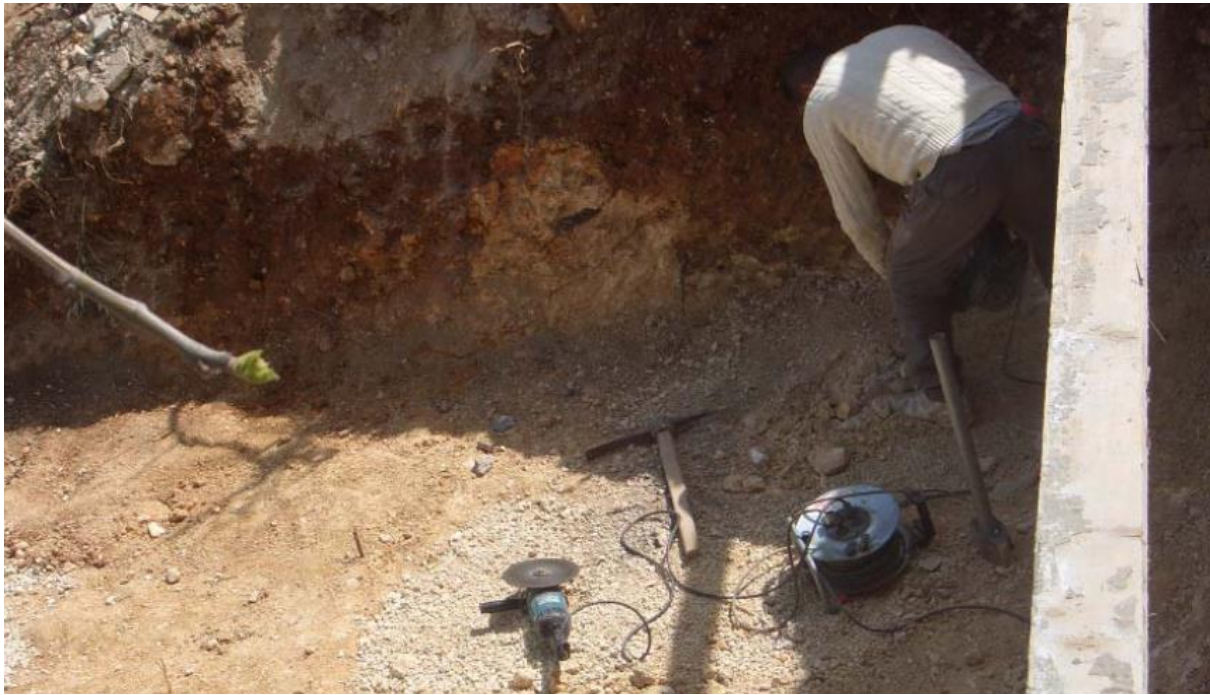
Figure 1: Excavation of the pit for the installation of the SBR tank.

Access to the site for mechanical equipment was not possible at all. Excavation and construction works were done manually by labourers. The top soil layers were removed easily but once deeper it took some efforts to dig in the bed rock. The site was also presenting a high pitched slope and precautions had to be taken during the construction to avoid landslides. The sewer line servicing the existing cesspit was conserved as back up but bypassed to reach the septic tank.

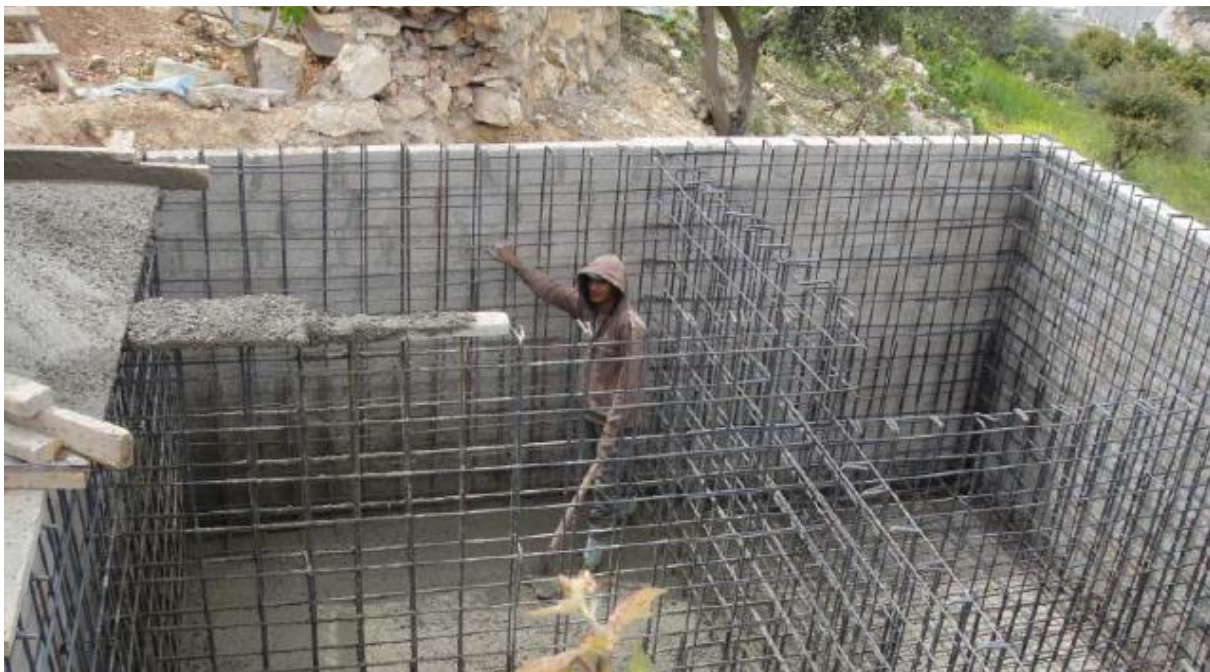
Figure 2: Pouring of the bottom concrete slab of the SBR tank.

This operation was done in 3 stages. First the floor concrete slab, then the external and internal walls and finally the roof concrete slab with the openings/block-outs for manholes and covers.

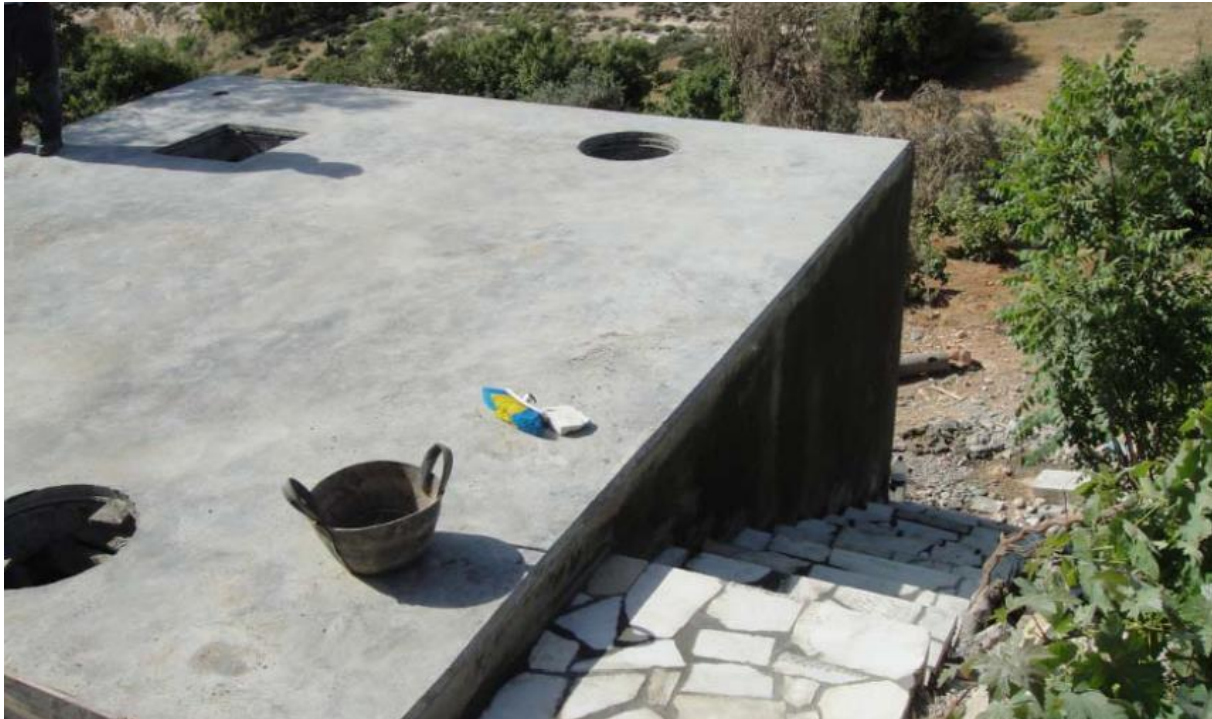
Figure 3: The SBR tank and the stairs after the end of the concrete work.

Upon removal of the internal formwork, it was necessary to finalize the connections to the sewer lines then to install a staircase to access the lower garden and install a guardrail as a safety precaution to prevent people from falling from the roof of the concrete tank (it has been made to be used as a terrace). Of course cast iron manhole access covers have also been installed and the site was cleaned from trace of construction rubbles.

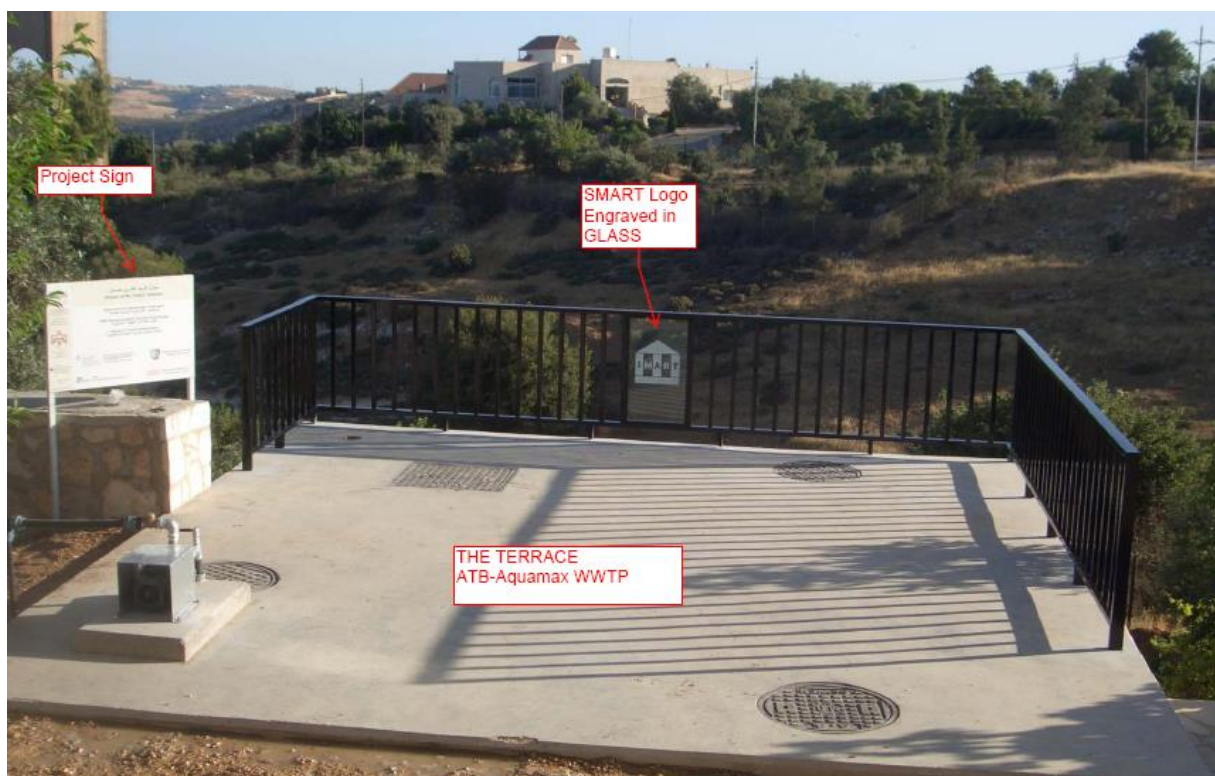
Figure 4: The SBR tank - the Terrace - after completion.

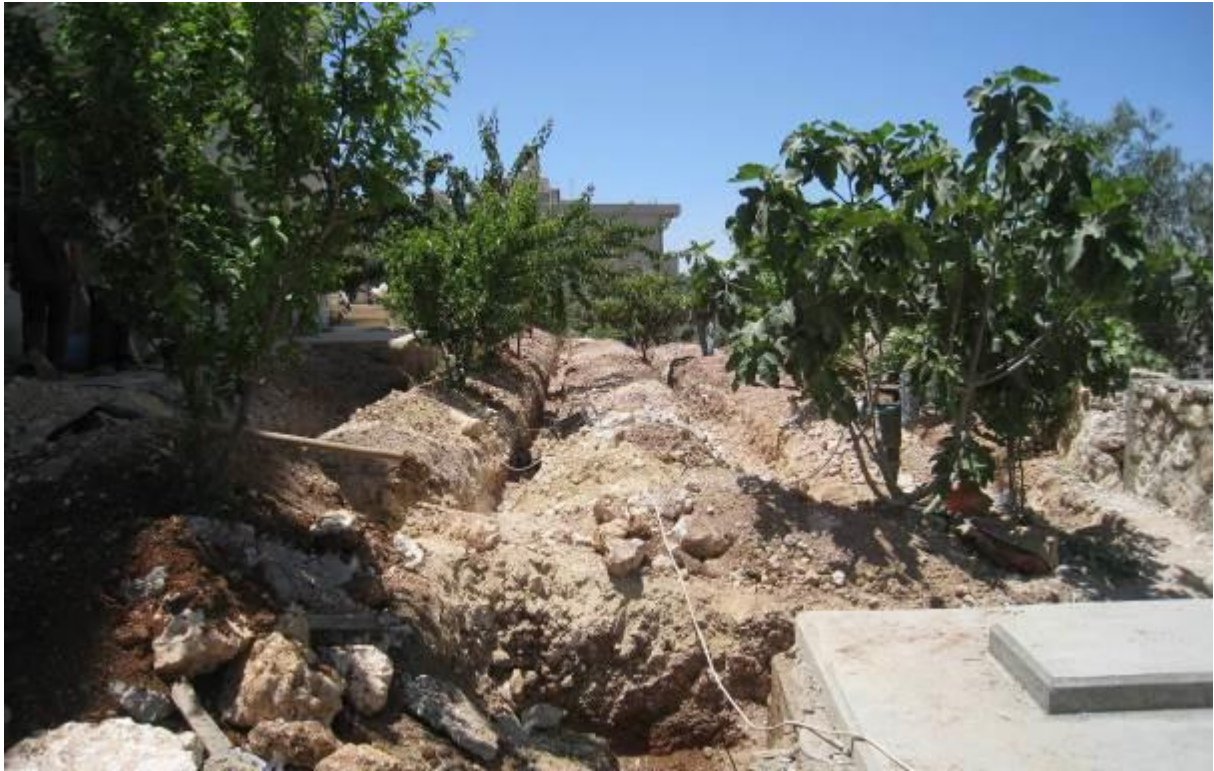
Figure 5: Excavation of the irrigation trench in the upper garden.

Again, due to the extreme topography of the site, all excavation work for the trenches has been done by labourers. The work was rendered even more difficult by the fact that the soil was very rocky in the lower garden. Also as subsurface irrigation was implemented, it has been necessary to lay the irrigation lines perfectly level and to have the same pipe cover above the lines. As such and due to the difficult site topography, it was necessary to level the ground along and around each irrigation line. The use of a 6-port indexing valve on this site required the levelling of 6 irrigation platforms. After the installation and testing of the irrigation lines, the trenches were filled back with the previously excavated soil.

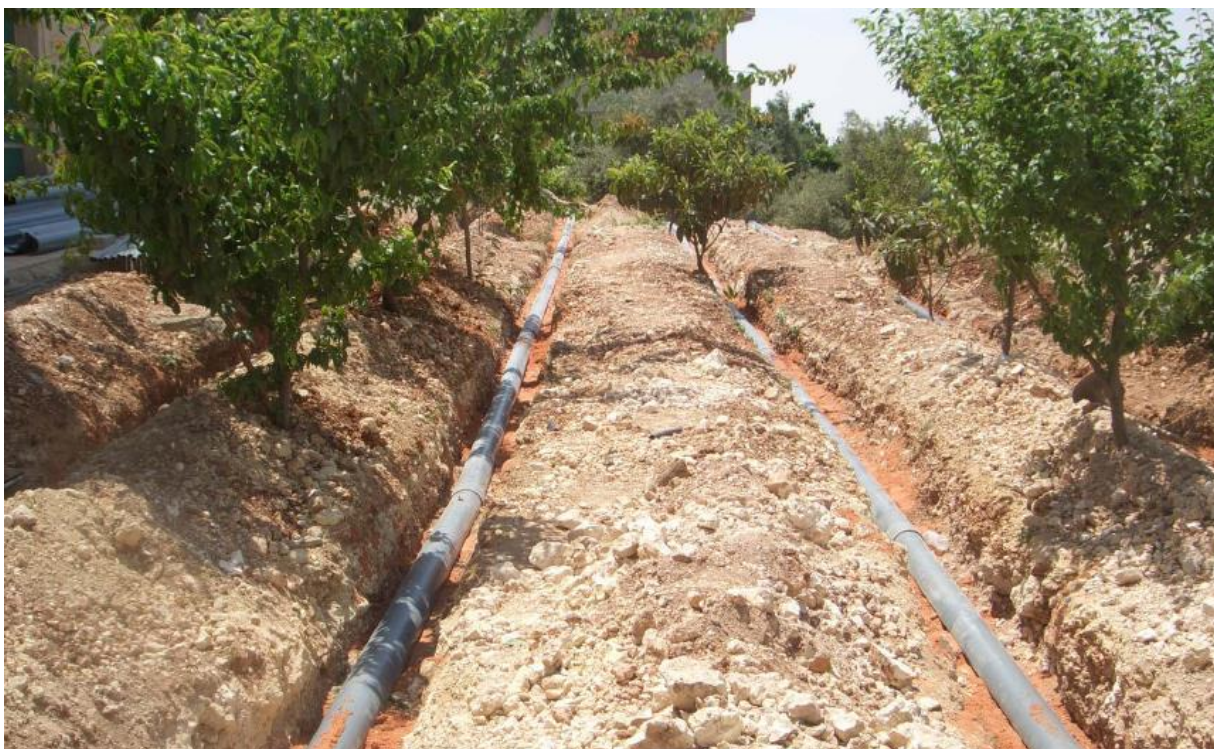
Figure 6: Installation of the subsurface irrigation lines in the upper garden.

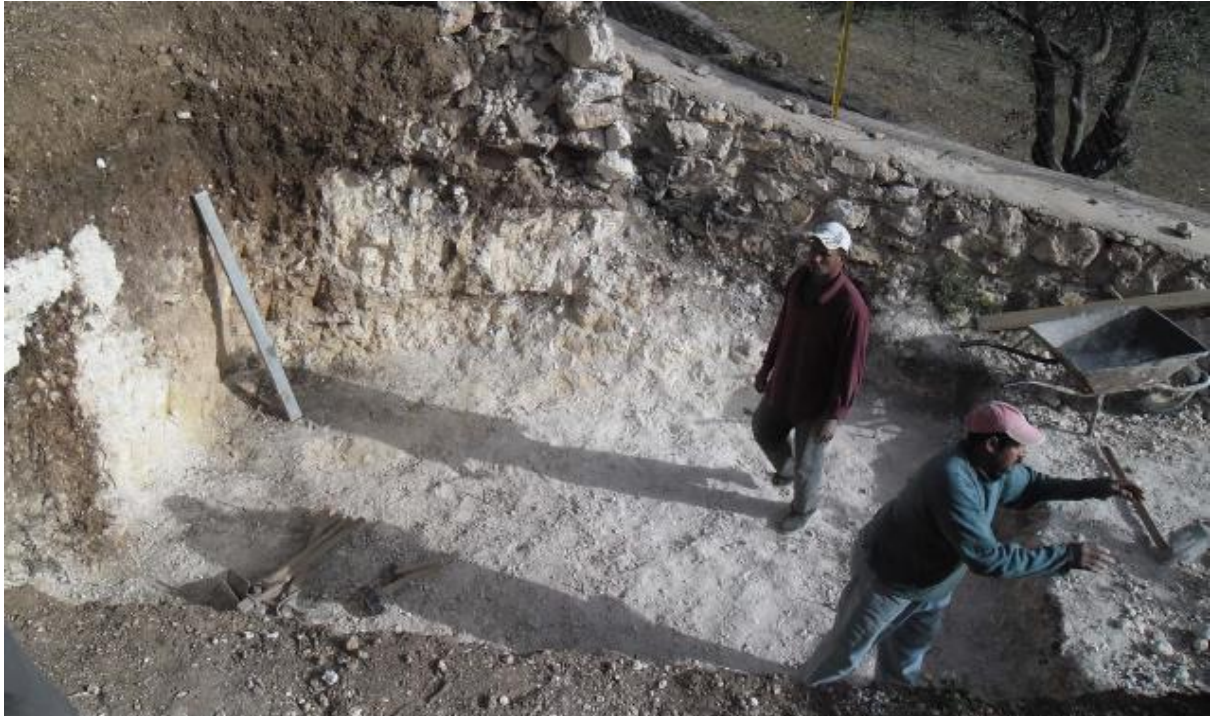
Figure 12: Excavation of the pit for the installation of the SBR tank.

Access to the site for mechanical equipment was not possible. Excavation and construction works were done manually by labourers. The work was facilitated by the fact that the location selected for the SBR tank was on a terrace, lowering the amount of excavation required. The top soil layers were removed easily but once deeper it took some efforts to dig some parts into the bed rock. Precautions had to be taken during the construction to avoid landslides. The sewer line servicing the existing cesspit was conserved as back up but bypassed (plus an emergency overflow) to reach the SBR tank. A new manhole was installed to replace the old collector.

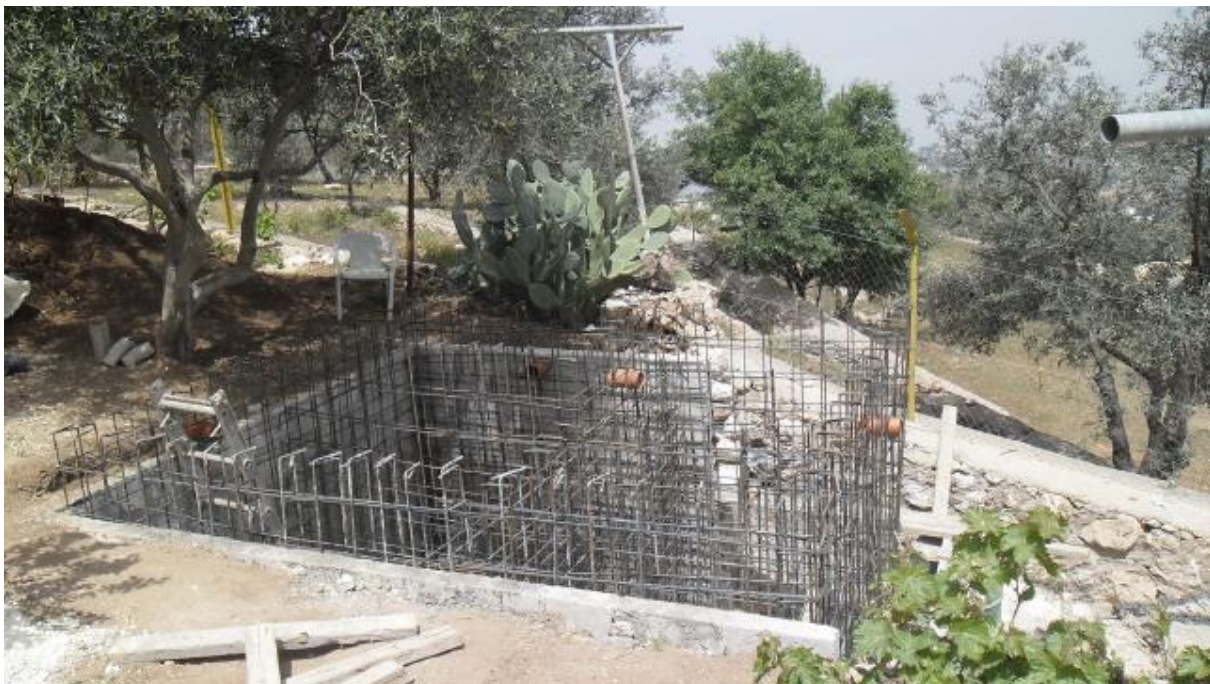
Figure 13: Construction of the steel frame of the SBR tank.

Considering the fact that the wastewater treatment system had to be installed on a sloped site, concrete blocks have been used for the 2.5 outer sides of the formwork of the structure. Once the excavation completed, planks were installed as internal formworks. The concrete reinforcement was done using reinforcing steel bars.

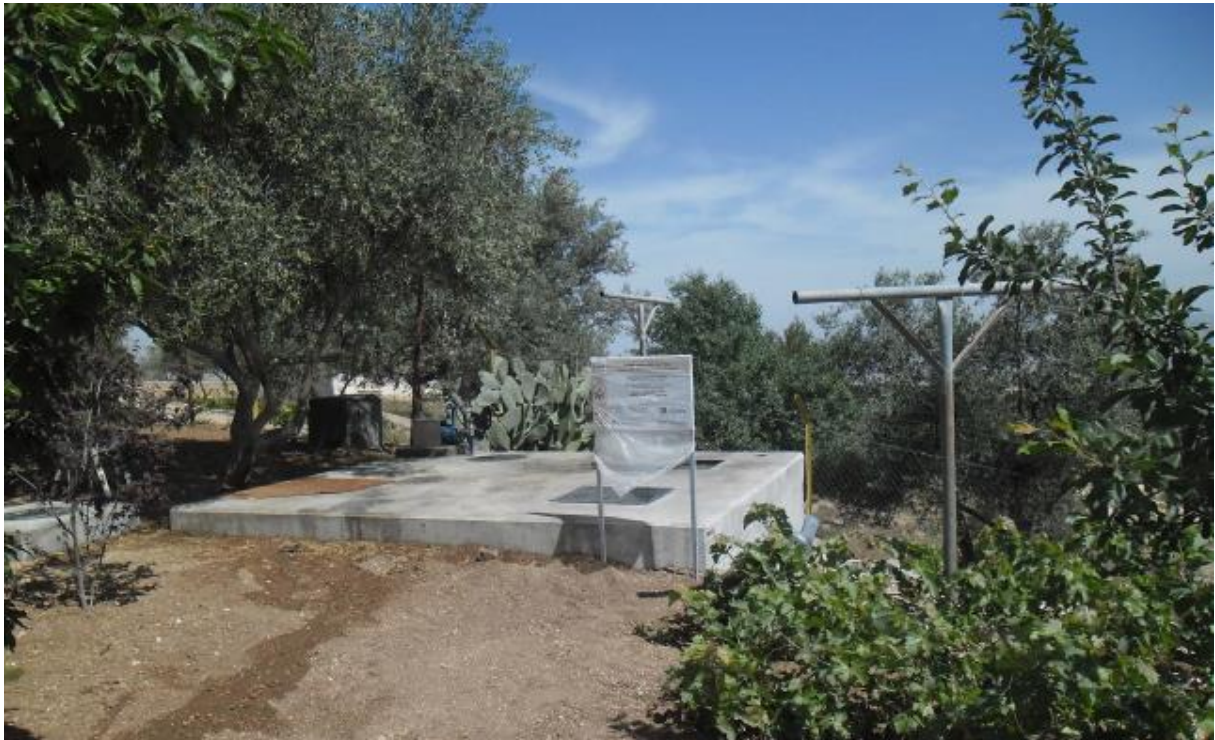
Figure 14: The SBR tank after the end of the concrete work.

This operation was done in 3 stages. First the floor concrete slab, then the external and internal walls and finally the roof concrete slab with the openings/block-outs for manholes and covers.

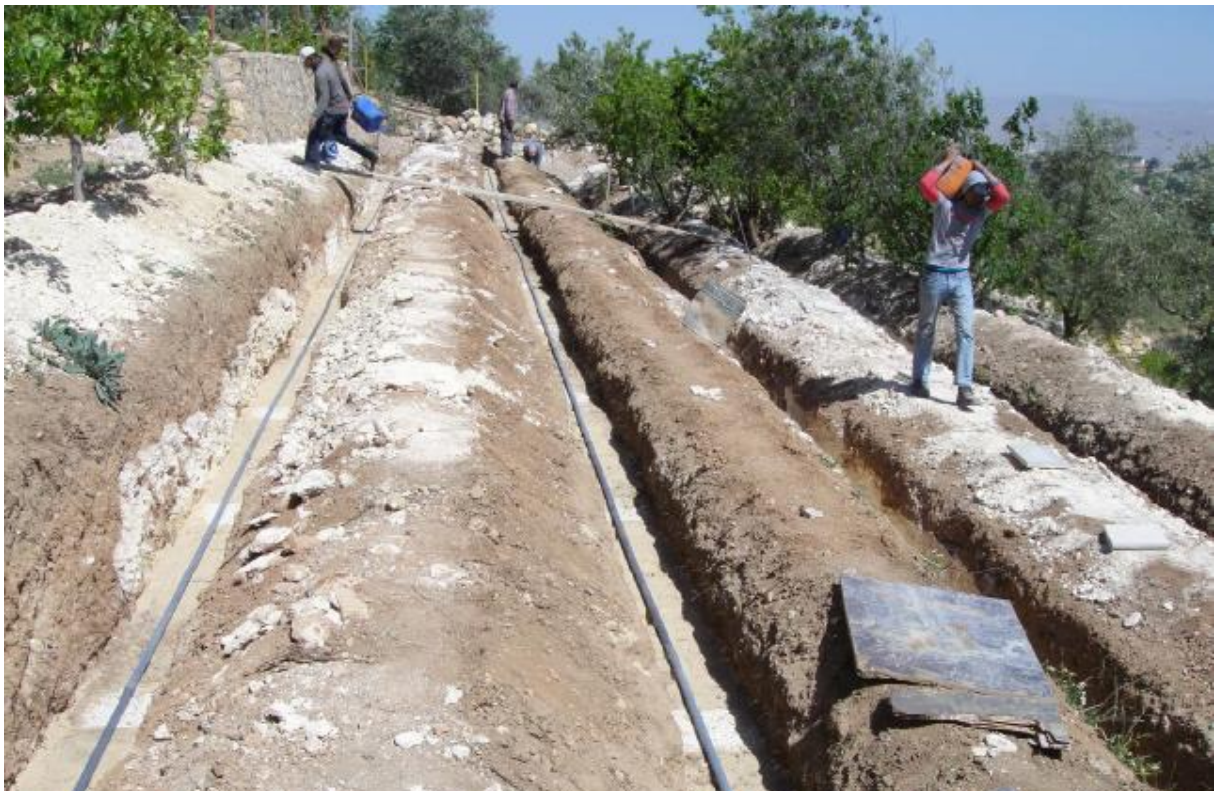
Figure 15: Installation of the subsurface irrigation lines in the garden.

Due to the topography of the site, all levelling and excavation work for the trenches has been done by labourers. As subsurface irrigation was implemented, it has been necessary to lay the irrigation lines perfectly level. The use of a 4-port indexing valve on this site required the levelling of 4 irrigation platforms of 2 lines. After the installation and testing of the irrigation lines, the trenches were filled back with the previously excavated soil.

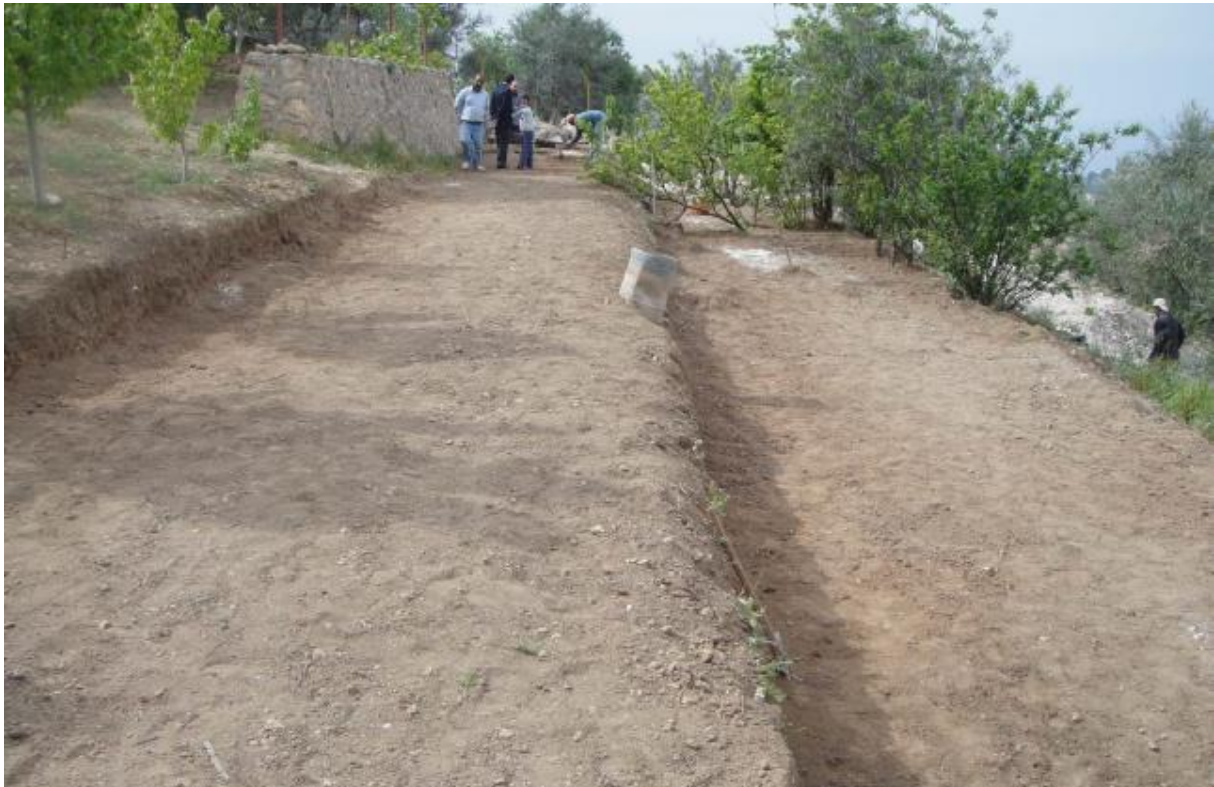
Figure 16: Mr Al Awamleh's garden after installation of the irrigation lines.

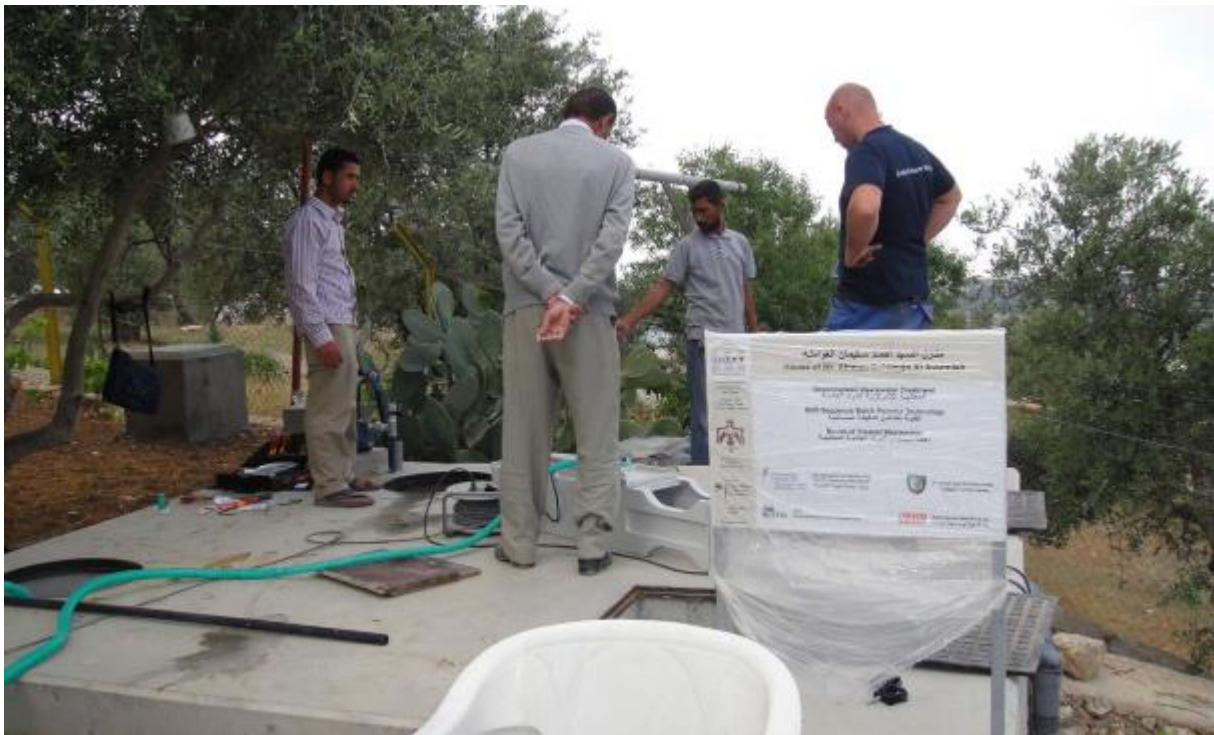
Figure 17: Installation of the SBR unit.

The installation of the SBR unit happened on the 16<sup>th</sup> of May and required a crew of two technicians from ATB in addition to the four workers (construction, plumber, electrician, and supervisor). The installation took about 2 days and went without trouble as the necessary infrastructure (piping and electrical cables) had been installed previously in order to optimise the working schedule of the technicians from ATB.

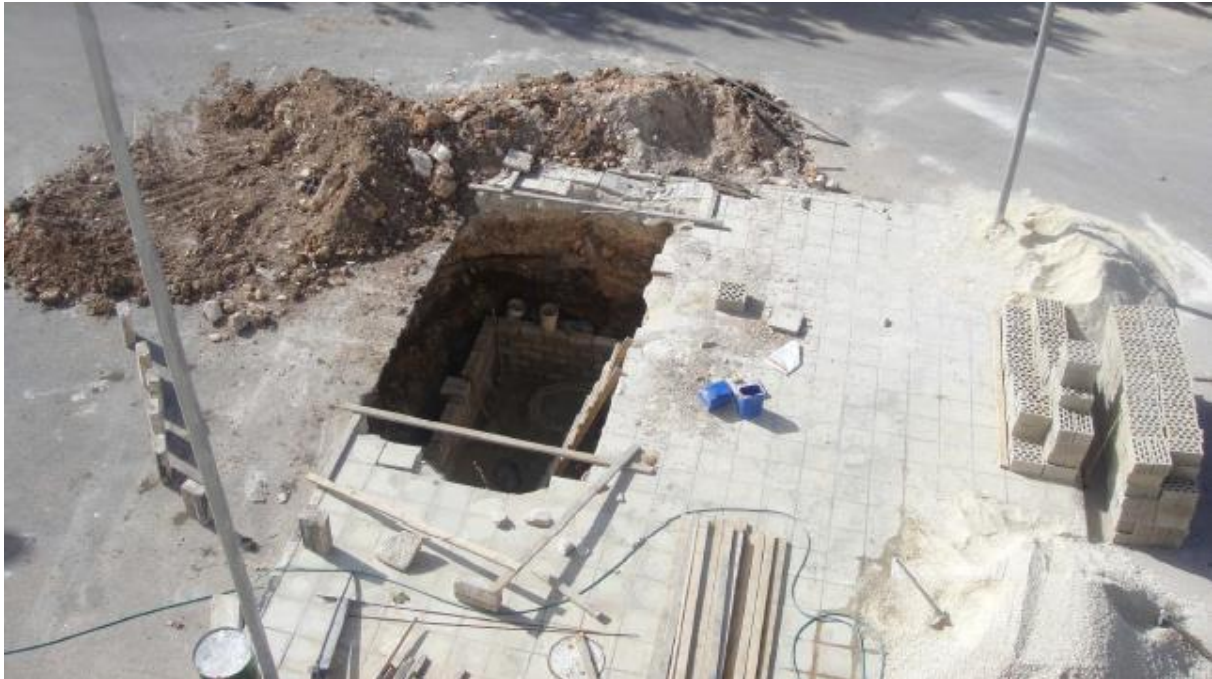
Figure 21: Excavation of the pit for the installation of the SBR tank.

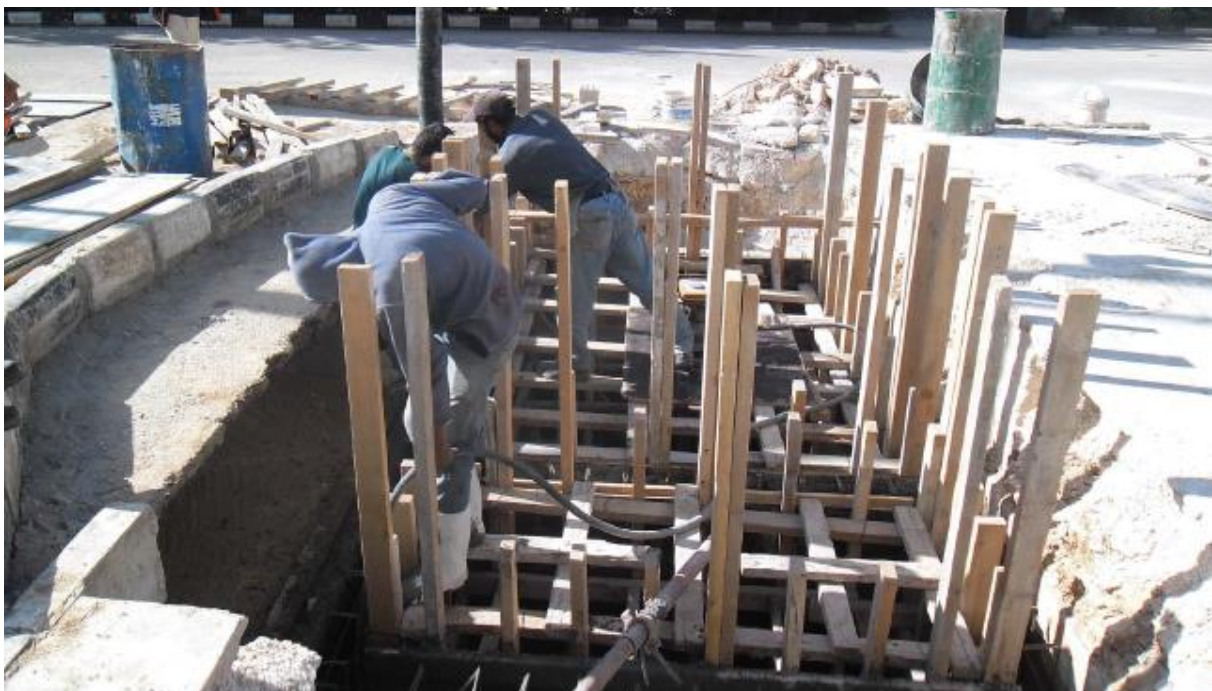
Figure 22: Construction of the frame for the SBR tank.

Process tank: Concrete blocks had to be used to reduce excavation dimensions (filling material, damage to the existing tiles and asphalt) for the outside formwork of the structure. Once the excavation completed, planks were installed as internal formworks. The concrete reinforcement was done using reinforcing steel bars.

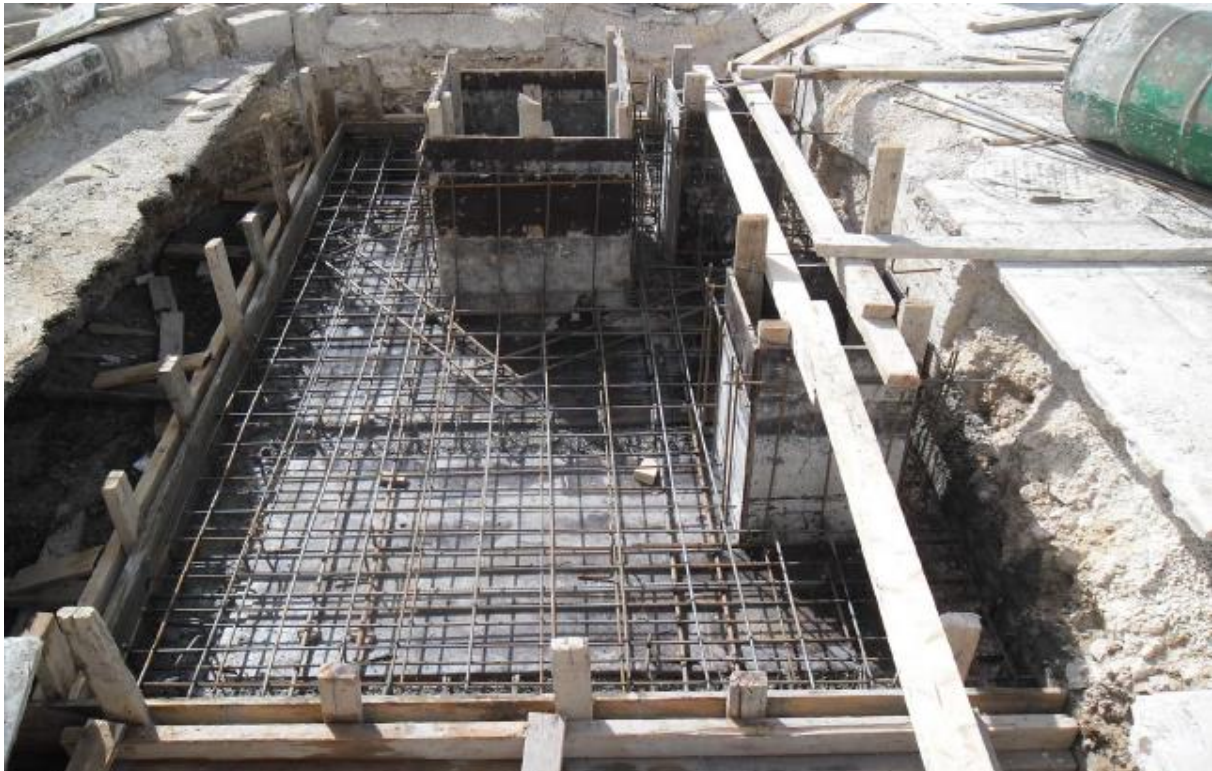
Figure 23: Construction of the top of the SBR tank.

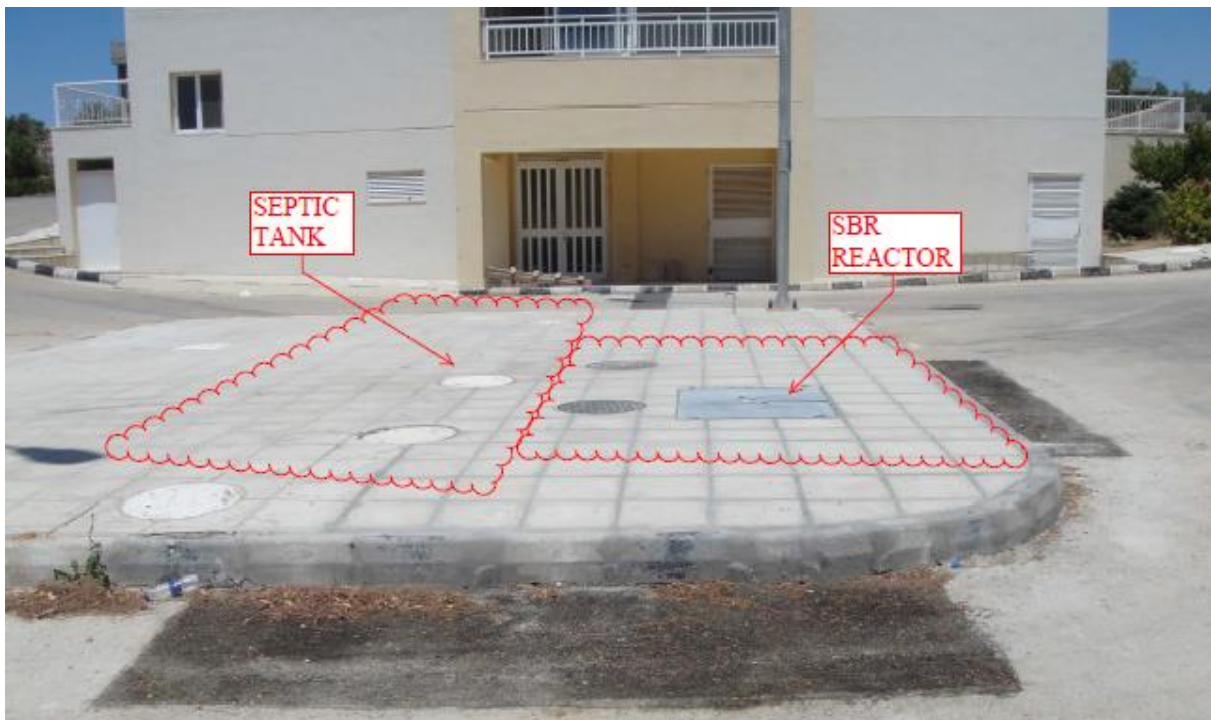
Figure 24: The SBR tank after completion.

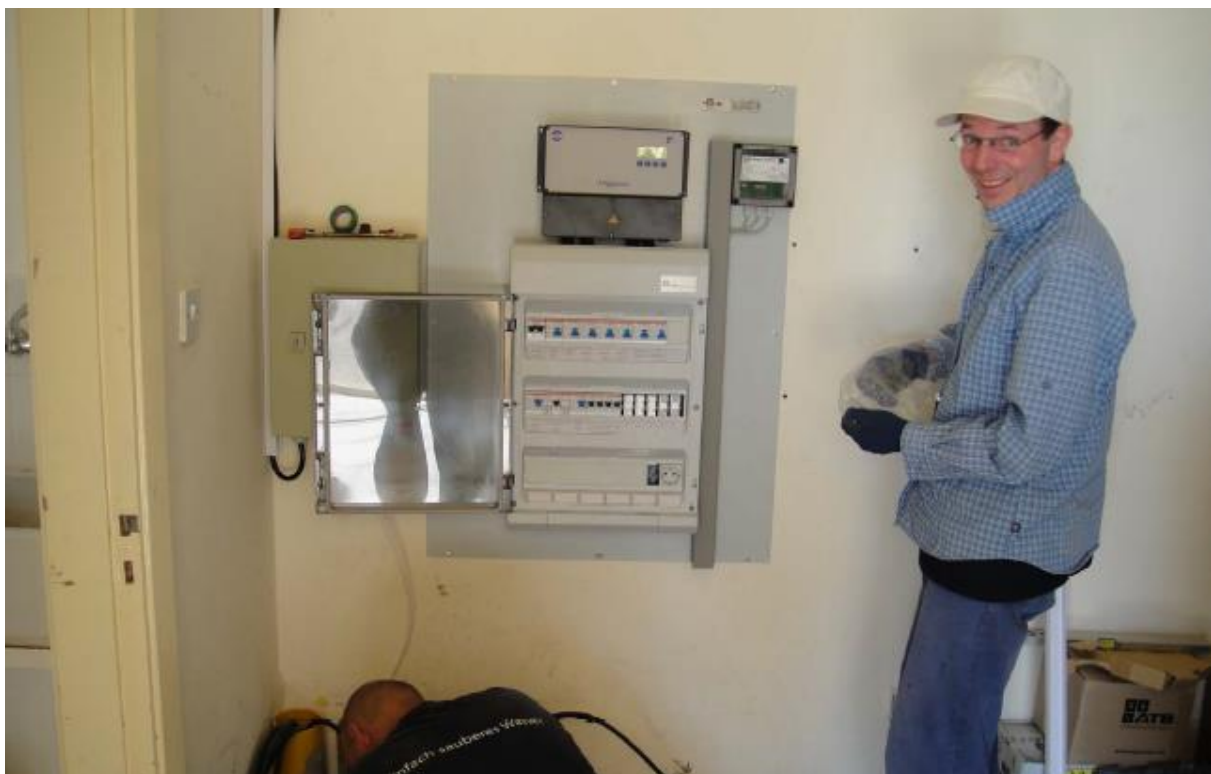
Figure 26: Installation of the control panel to operate the SBR.

Together with the main control panel the GSM module has been pre-installed on a mounting plate. In the course of the installation of the electrical and machinery equipment also this pre-installed GSM module has been activated. Messages will be sent to the mobile phone of Mr. Nabil Wakileh, NAW/WES. In the beginning there were a lot of error messages sent out. Together with the GSM modem supplier/manufacture ATB detected the fault (which was caused by an English vocabulary). After the correction of the programme the system is working properly. [Deliverable 307]

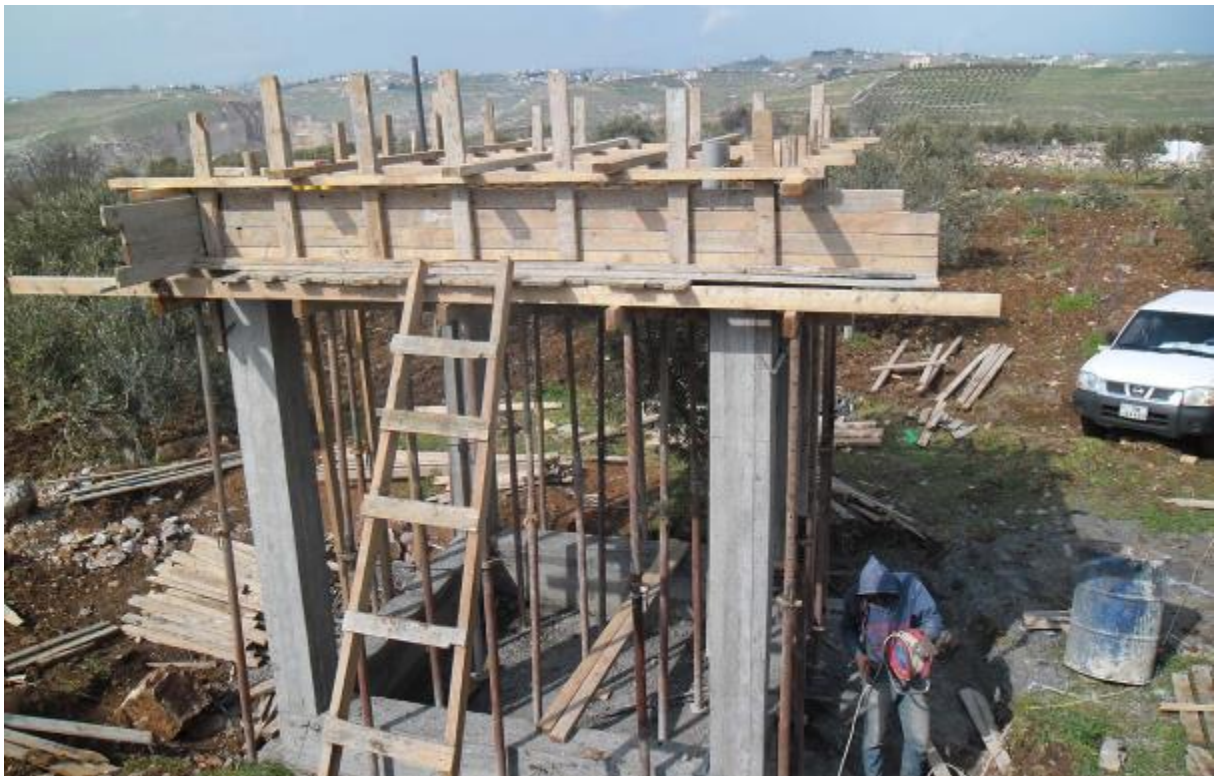
Figure 27: Construction of the water tower in the garden.

Irrigation tower: excavation was realised to install concrete foundations.

Irrigation tower: this operation was done in five stages. First the blinding concrete, then the foundations, then the pillars then the roof slab then the floor slab. Concrete block were installed to close the space between the pillars to create a storage room.

Irrigation tower: curing time for the tower took overall 20 days: two day for the foundations, three days for the columns, 14 days for the roof and one day for the floor.

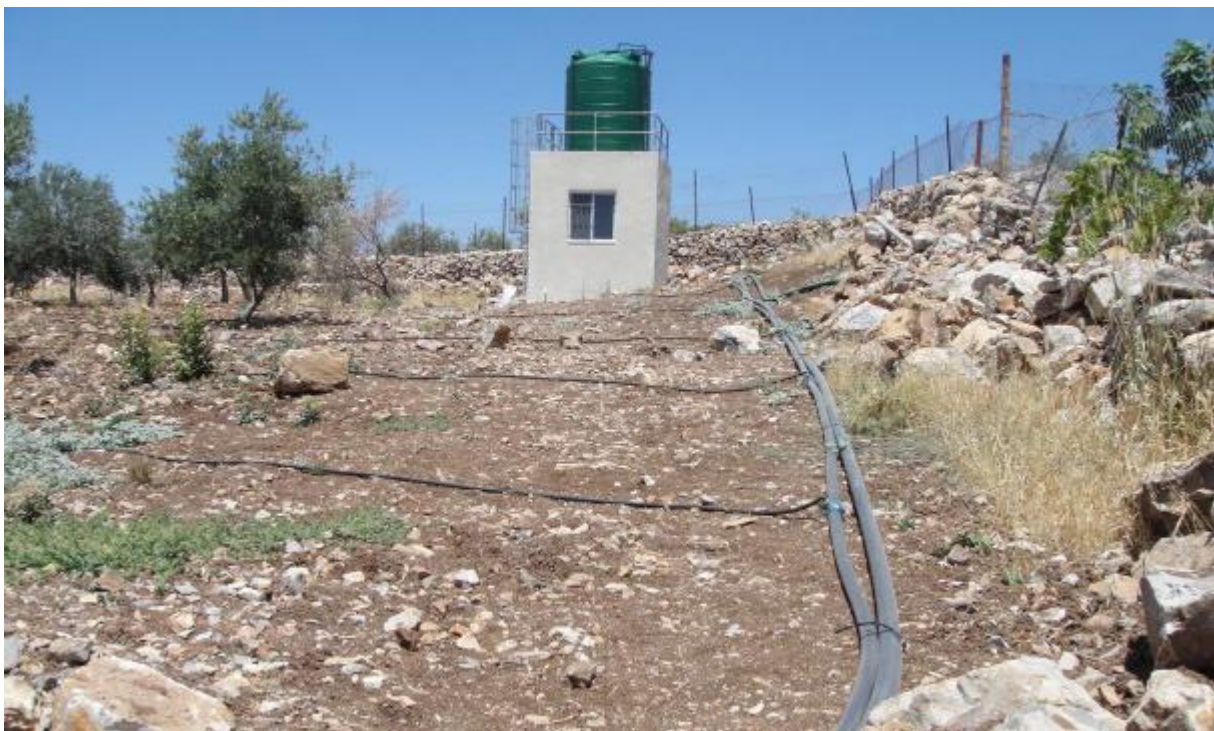
Figure 28: The water tower, its storage room and the drip irrigation lines after completion.

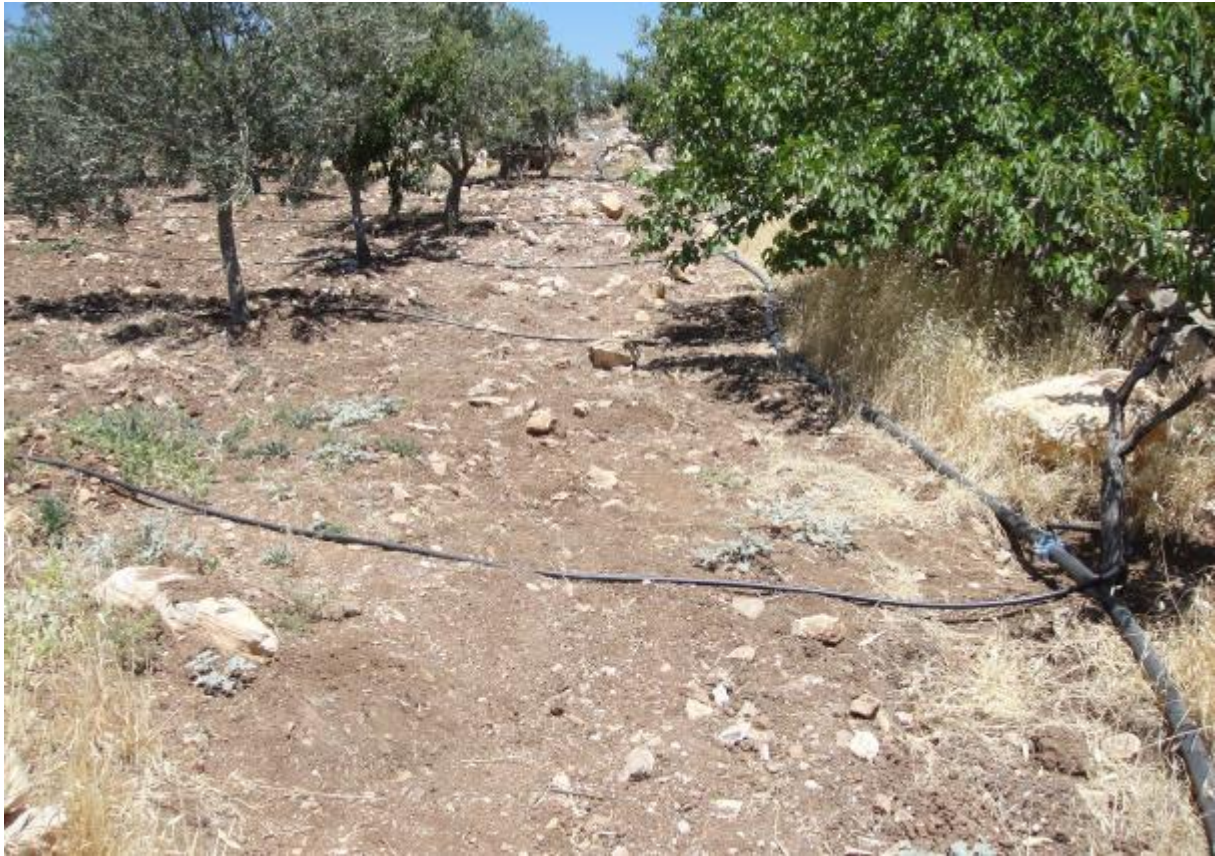
Figure 29: The drip lines installed in the reuse area.
